Yukon Energy Corporation

# **Marsh Lake Storage Concept: 2011 Geomorphology Field and Associated Studies Report**

AECOM

December 2011

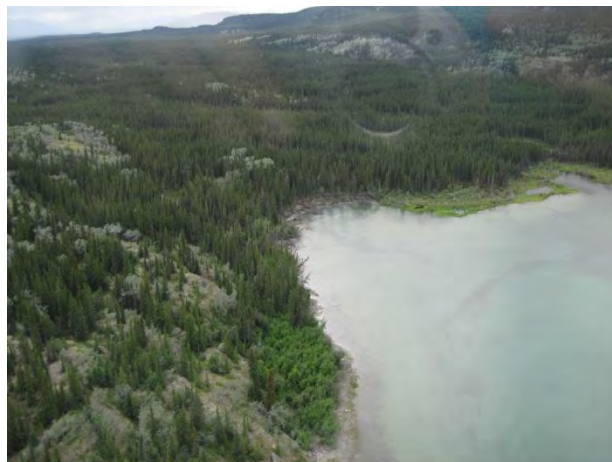
**Photograph 2**

Fine grained bluff eroding from North winds and/or melting permafrost.

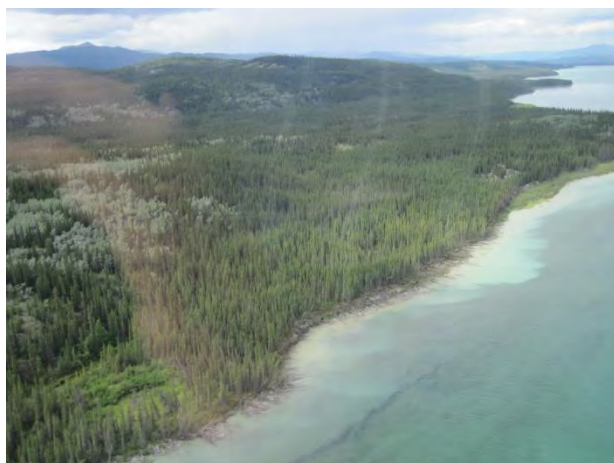
**Photograph 3**

Fine grained sediment eroding at low bank with turbid water offshore.

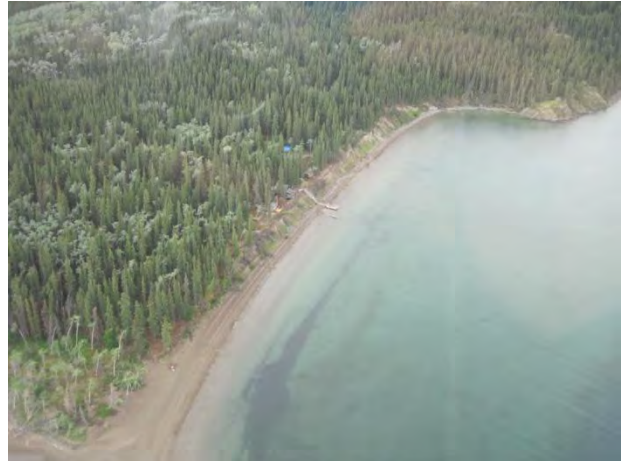
**Photograph 6**

High, fine grained bluff eroding from North winds. Cabins and small dock directly adjacent to eroding bluff.

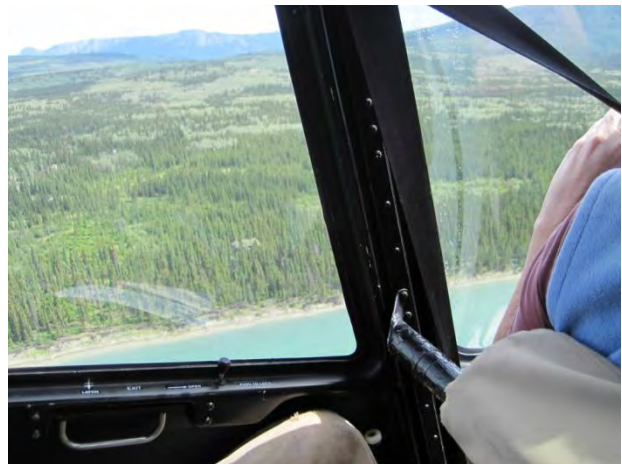
**Photograph 8**

Tagish River bank erosion.

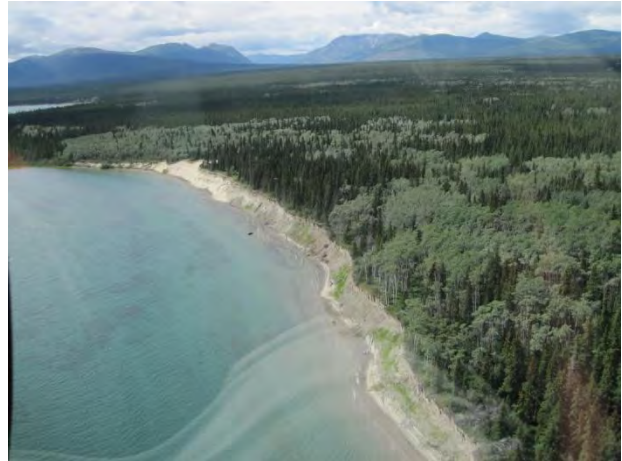
**Photograph 10**

High, fine grained bluff eroding along Tagish River.

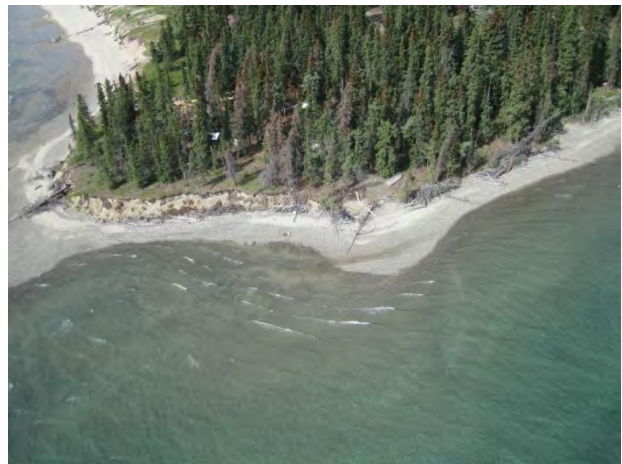
**Photograph 12**

High, fine grained bluff eroding along Tagish River.  
Houses all along eroding bank.

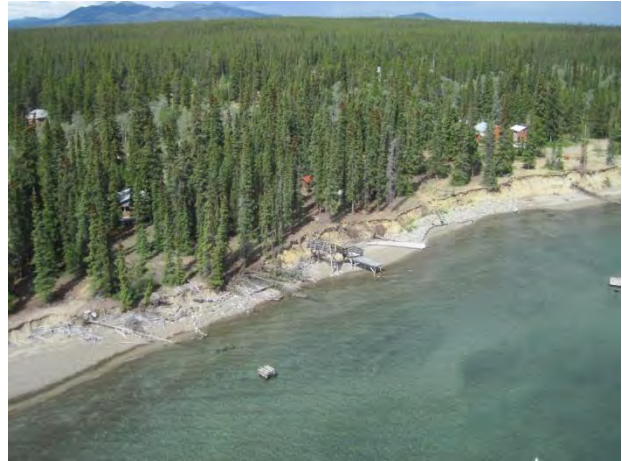
**Photograph 14**

Fine grained sediment eroding along high bank. Houses all along bank.

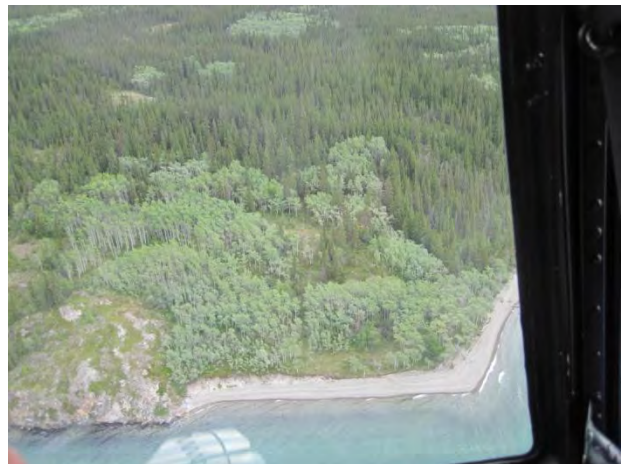
**Photograph 16**

Low, fine grained bluff eroding.

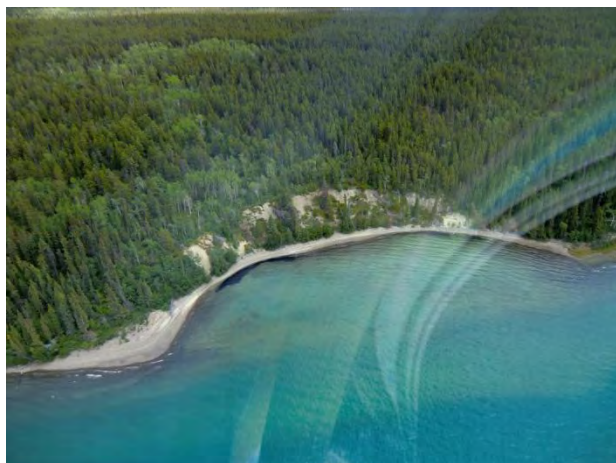
**Photograph 17**

Fine grained sediment eroding along high bank.

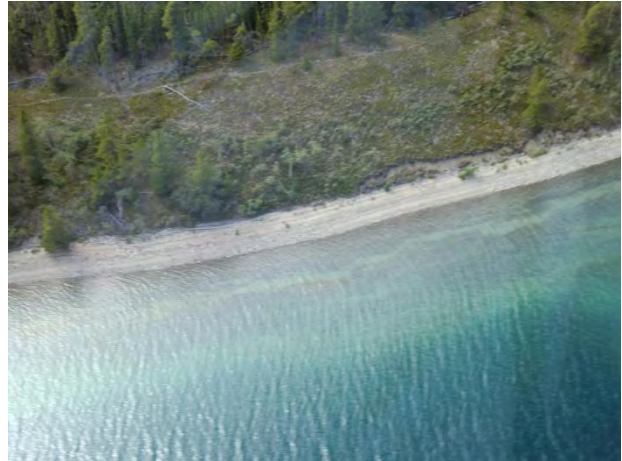
**Photograph 22**  
Slumping fine grained sediment eroding along low bank.

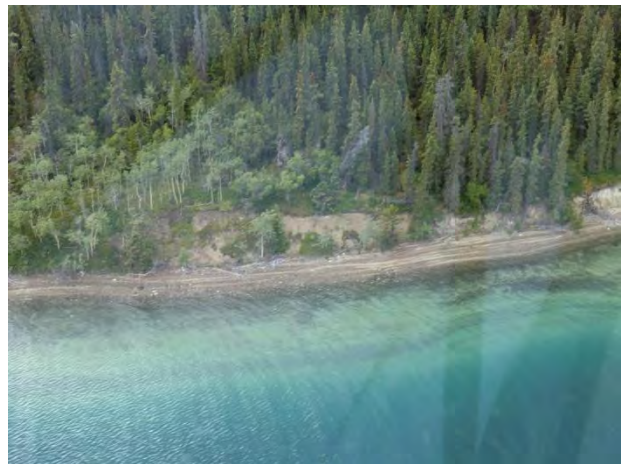
**Photograph 24**  
Low bank erosion of fine grained sediment.

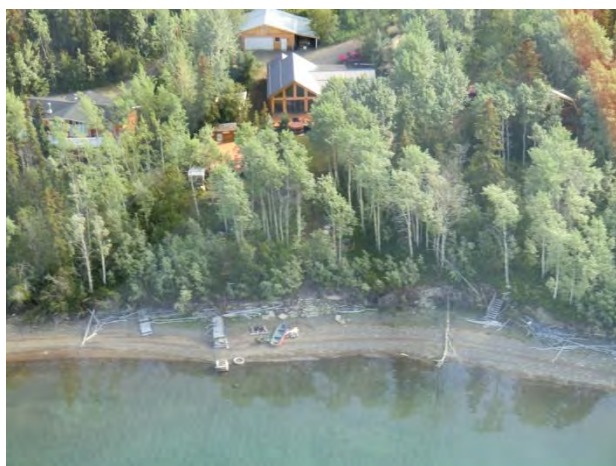
**Photograph 35**

Low to medium high bank with very fine grained sediment eroding along shore. Anderson's property.

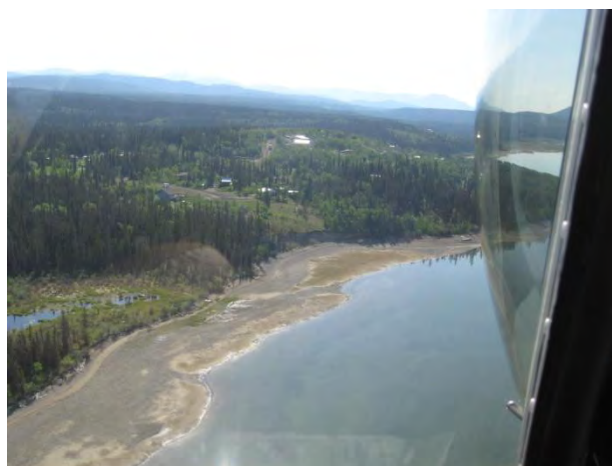
**Photograph 36**

High bank, fine grained sediment eroding along shore within Judas Creek Subdivision.

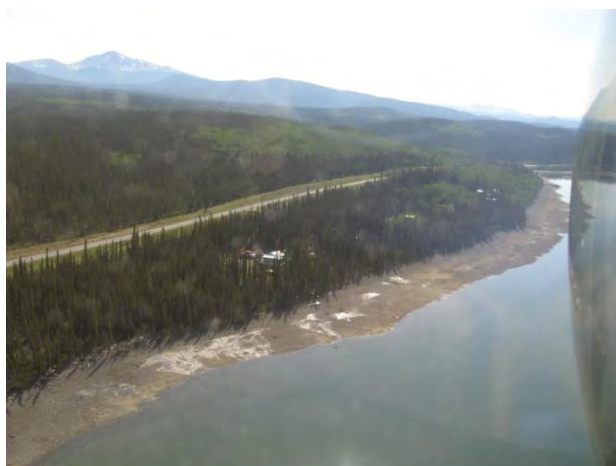
**Photograph 39**

Low bank with fine grained sediment eroding along shore. Properties adjacent to erosion.

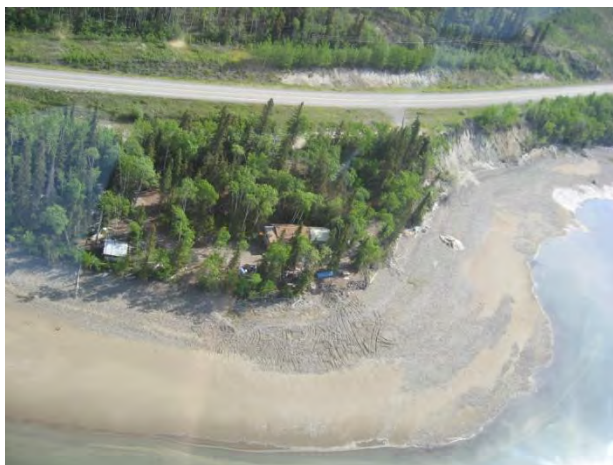
**Photograph 43**

High bank with fine grained sediment eroding along  
shore. Property adjacent to erosion.

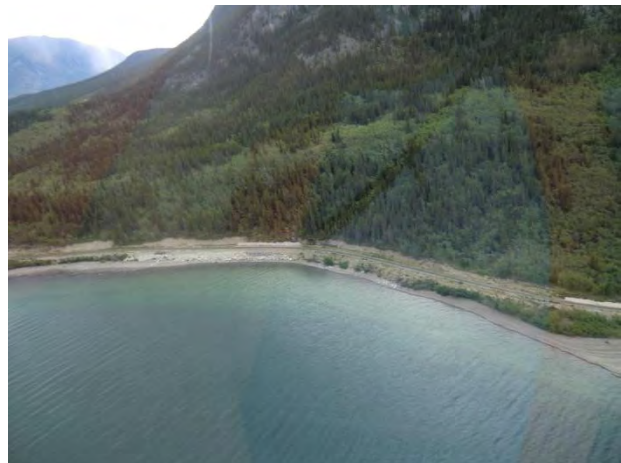
**Photograph 52**

Whitepass railway near shore of Bennet Lake. Revetment repair appears recent (white boulders).

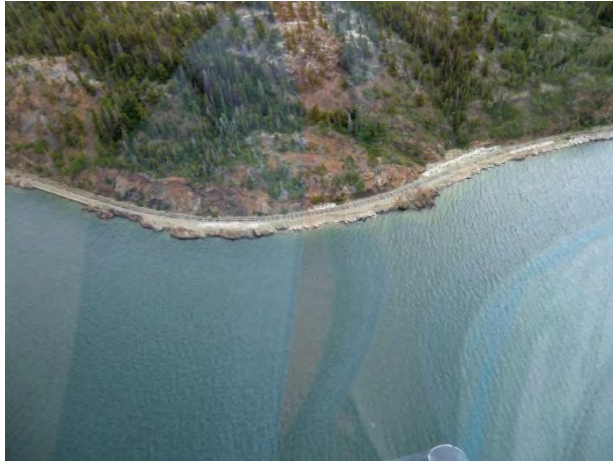
**Photograph 53**

Whitepass railway near shore of Bennet Lake. Revetment repair appears recent (white boulders). Some erosion is evident.

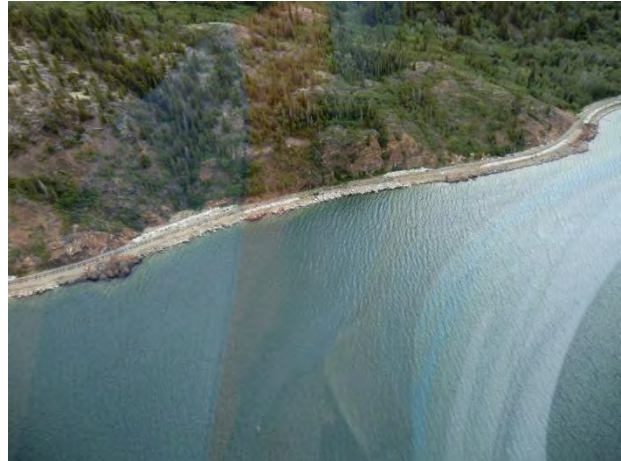
**Photograph 54**

Whitepass railway near shore of Bennet Lake. Several revetment repairs range from recent (white boulders) to old. Some erosion is evident.

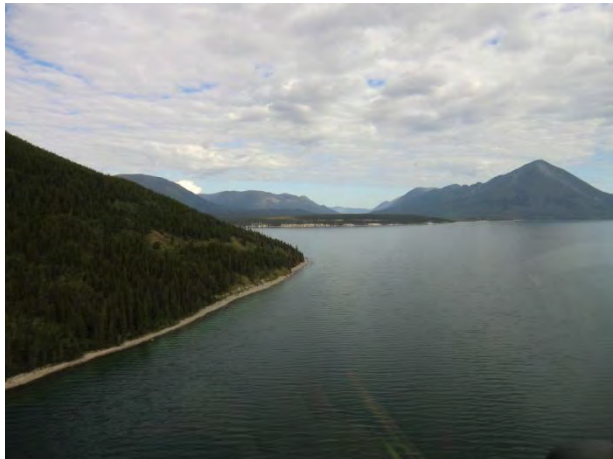
**Photograph 55**

Low to moderate high bank with fine grained sediment eroding along shore of Bennet Lake.

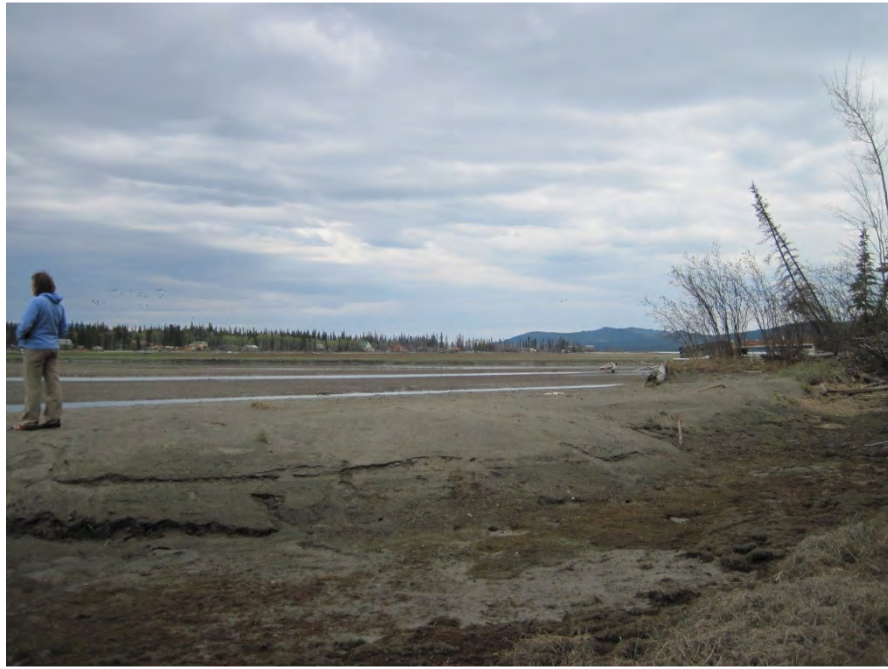
- A small sand/silt spit was observed immediately north of Lot 1039. The approximate area of the spit was 250 m<sup>2</sup> and was about 1.0 m in height (Photo 1). This suggests that wave action may be transporting and depositing eroded bank and bluff sediments northwards along the beach of North M'Clintock.

**Photograph 1.** Small sand/silt spit at north end of M'Clintock Bay, north extent just beyond view on left side of photo.

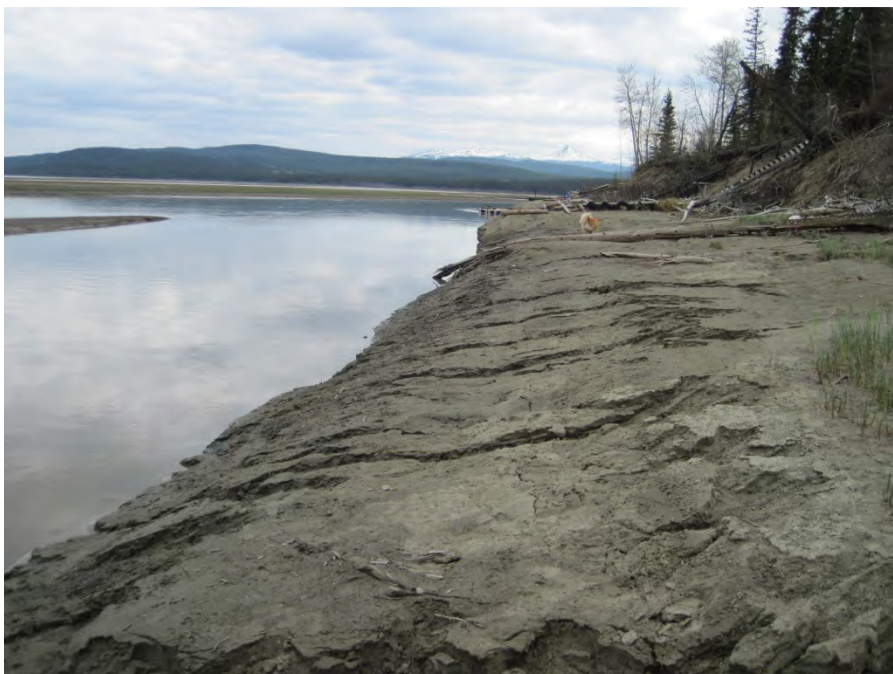
**Photograph 3.** The two channels of M'Clintock River join (flow is from bottom to top of photo). Rill erosion along the M'Clintock river bank is also evident here (small gullies flowing right to left on photo)..

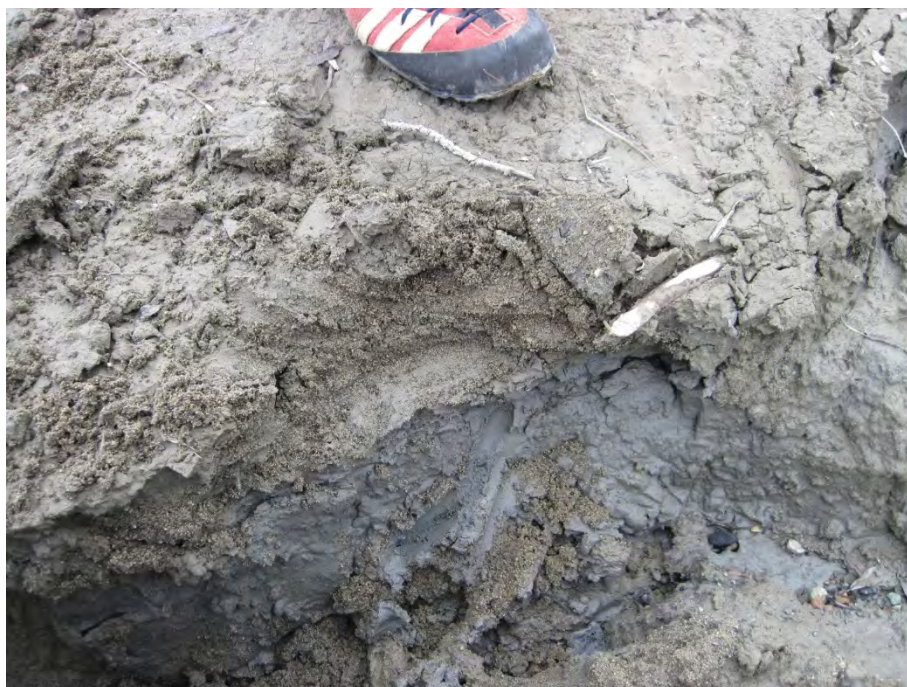
**Photograph 4.** Along the M'Clintock River banks a layer of silt washed from the erosion bank covers a clay deposit.

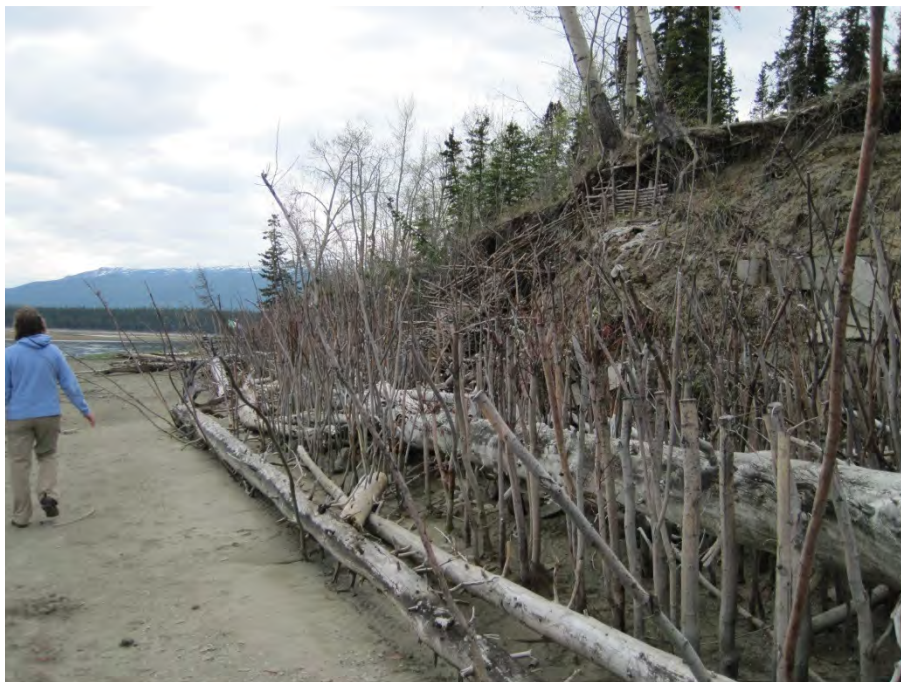
**Photograph 5.**

Lots 393, 392, and 1040 have employed willow plantings to help reduce shoreline erosion from wave action.

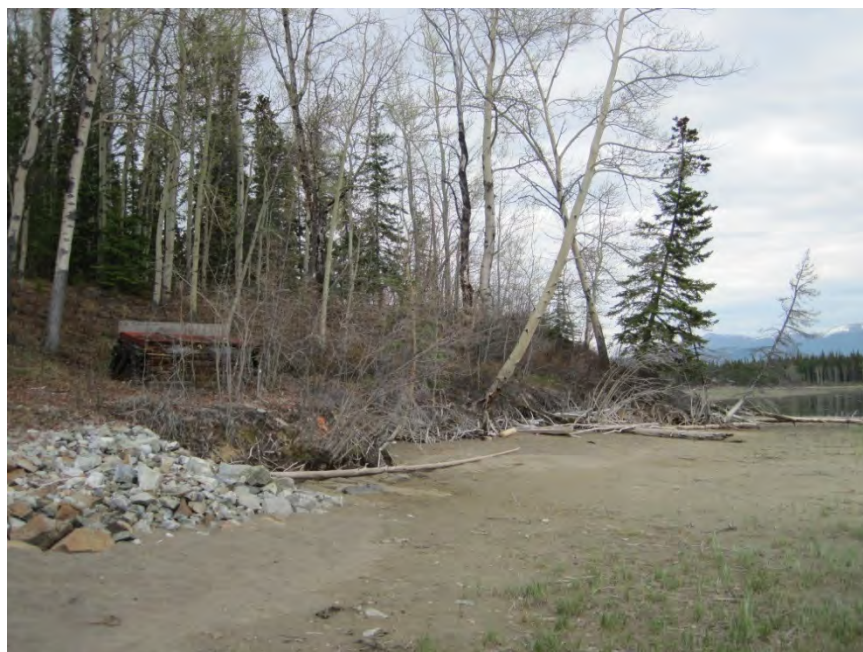
**Photograph 8.** Bluff south of bedrock outcrop (situated at Lot 1026) is more stable and shorter in height.

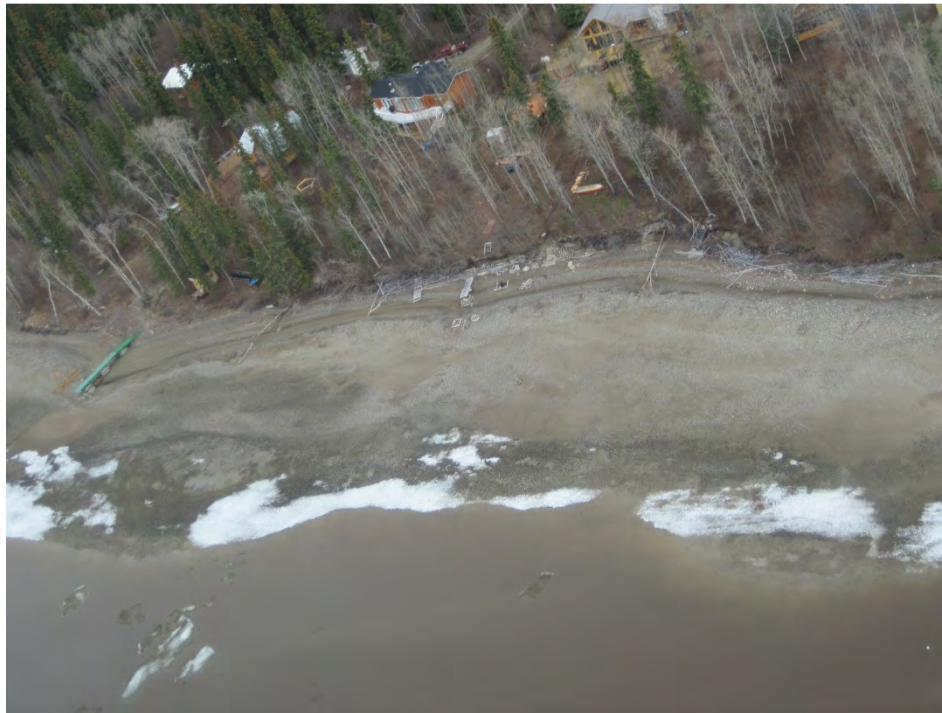
**Photograph 1.** Areal view of erosion bluff near Andersons property line (Lot 77 – centre of photo).

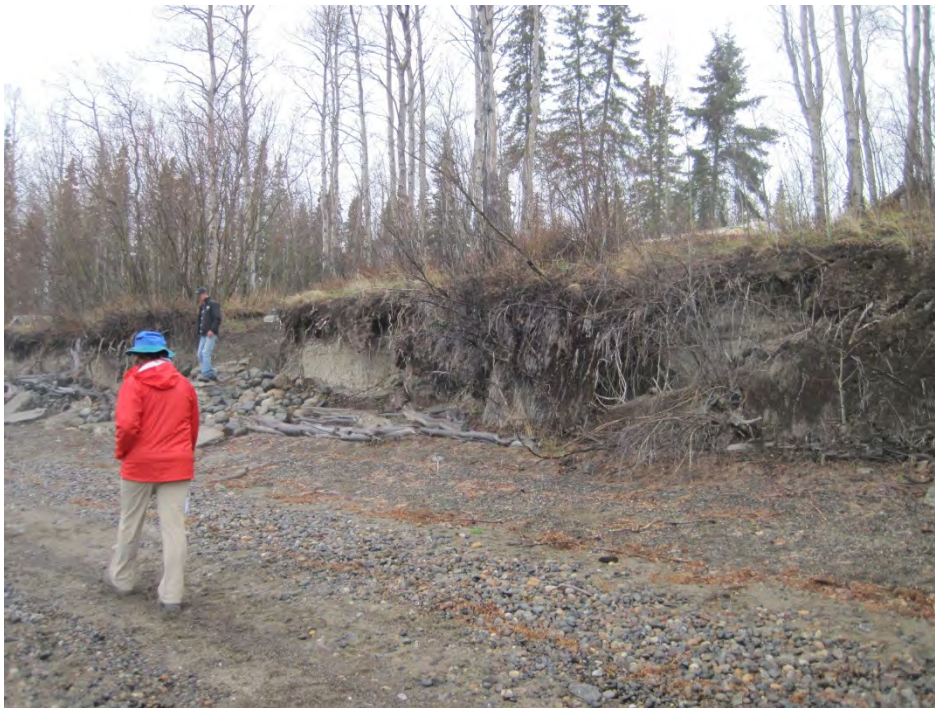
**Photograph 2.** Ground view of erosion bluff near Andersons property line.

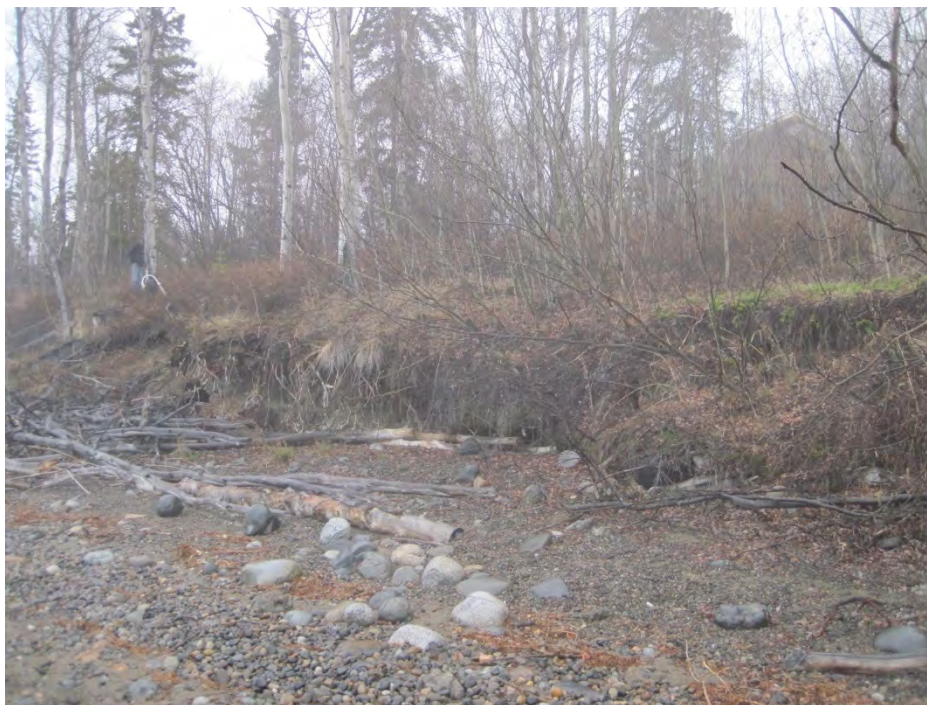
**Photograph 3.** View of erosion bluff near Lot 78, south of Andersons Lot 77.

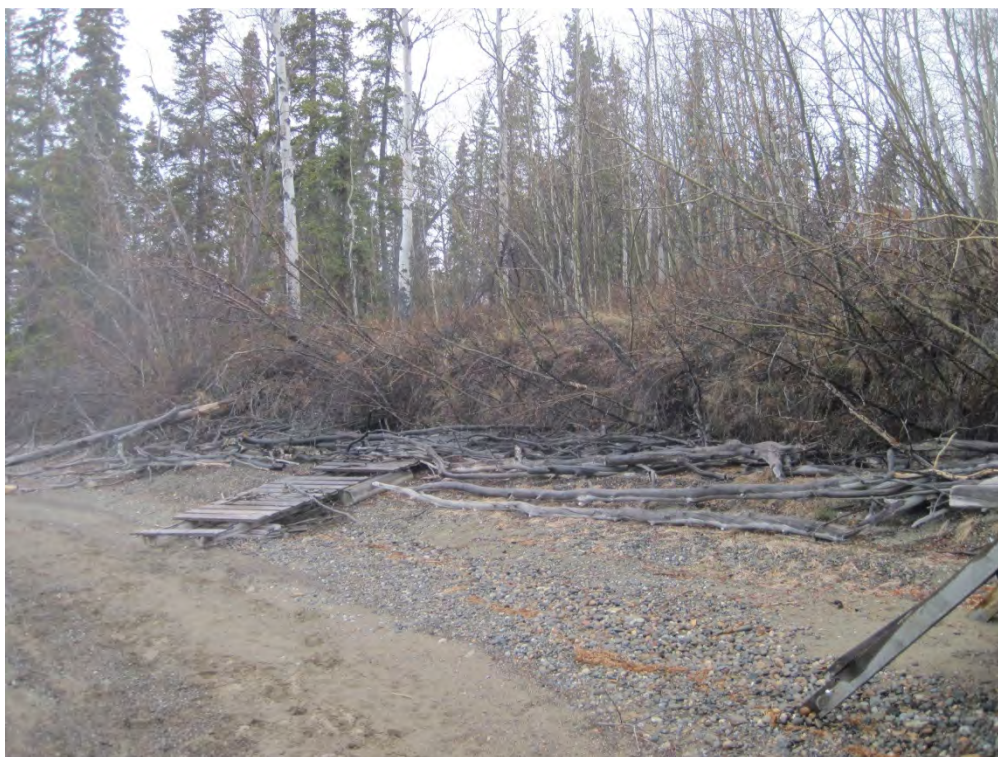
**Photograph 4.** View of erosion bluff near Lot 76, north of Andersons Lot 77.

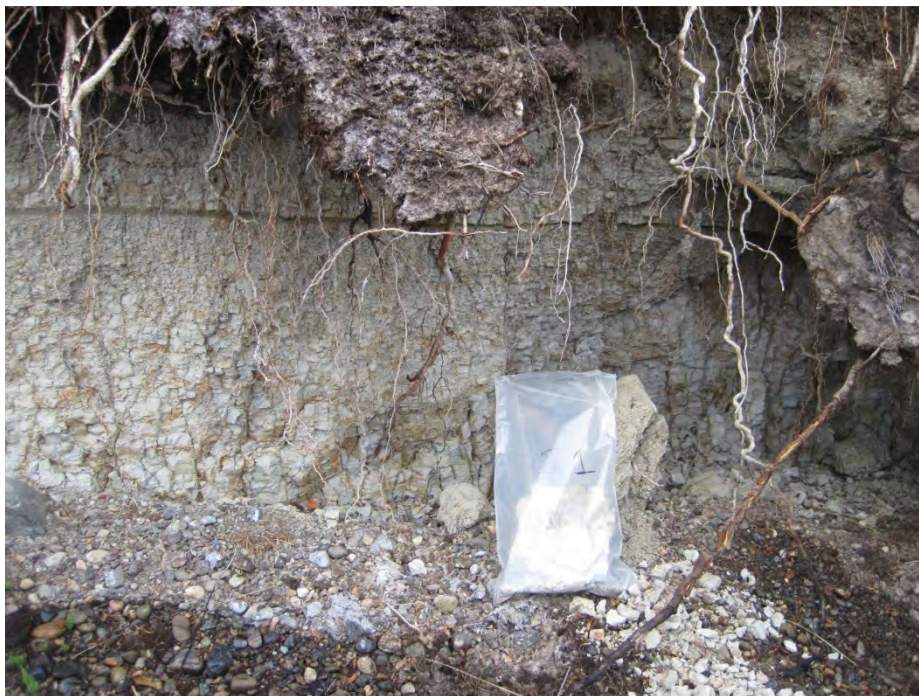
**Photograph 5.** Close-up of clay material at erosion bluff near Lot 77.

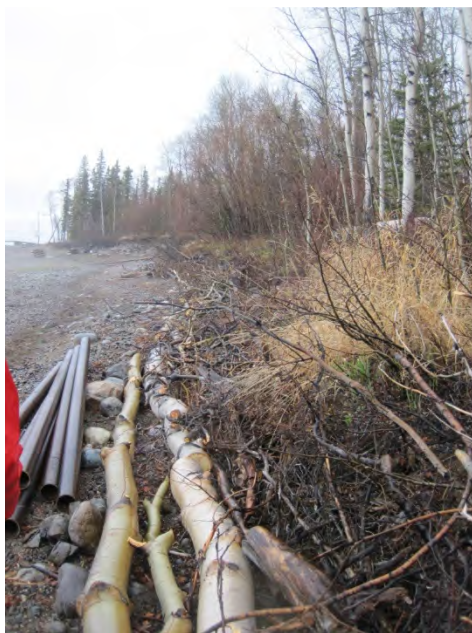
**Photograph 6.** View of erosion protection (logs) near Lot 79.

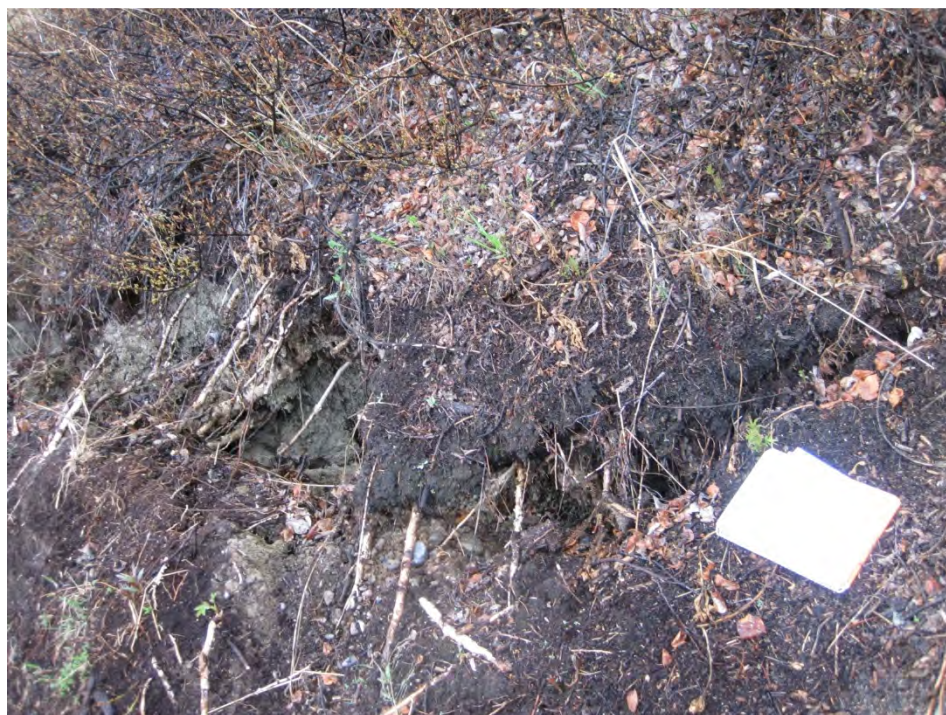
- remaining bluff extending away in both directions from the Anderson's Lot. A thin vegetation veneer caps the surficial layer along the bluff.
- The bluff near Lot 78 has visible slump cracks where the bank is slowly breaking off onto the beach (photo 8).
  - Three sediment samples were collected along the shoreline and bluff adjacent to the Anderson's property – see table 1 below.

**Photograph 8.** View of slump cracks along erosion bluff near Lot 78.

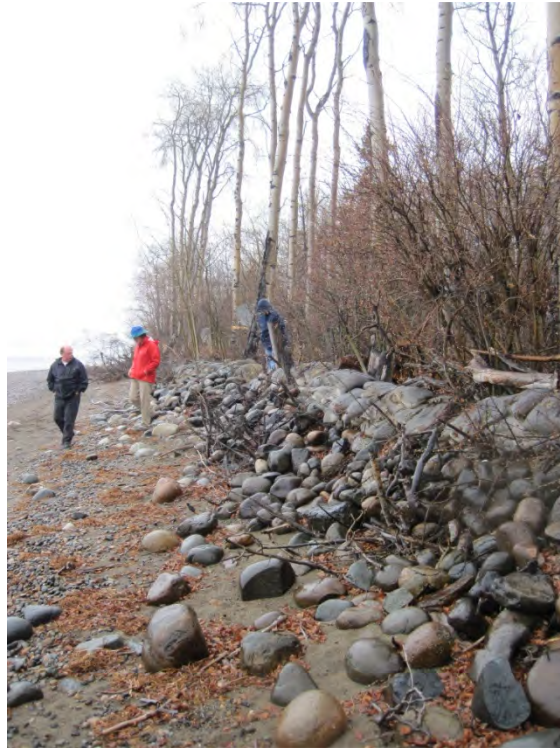
**Photograph 9.** View of flood and erosion protection (boulders and sandbags) near lot 83.

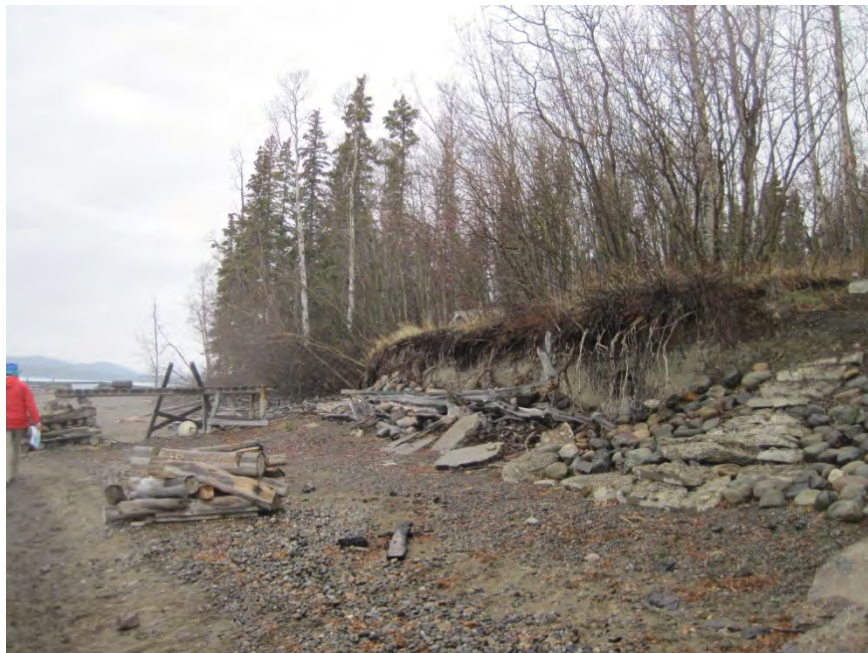
**Photograph 10.** View of erosion bluff near Lot 77 with some erosion protection (logs and boulders).

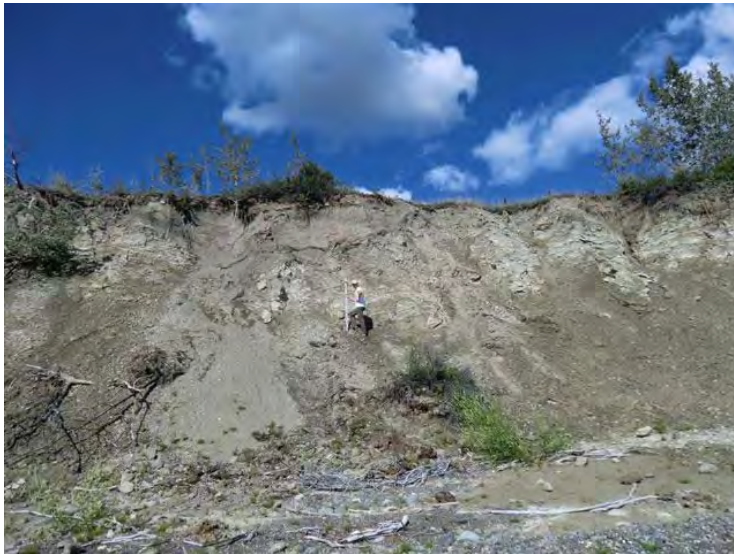
**Photograph 4.** Shoreline bluff south of KDFN S-206

4. Visit to shoreline bluff south of KDFN S-206 along Alaska Highway – high glacio-lacustrine bluff subject to erosion. Beach transect presented in Figure 2.
