Mayo Lake/Daghro Män/Ts'agro Män Ice Monitoring Program

February 2026

Ice Observation – Feb 20, 2026

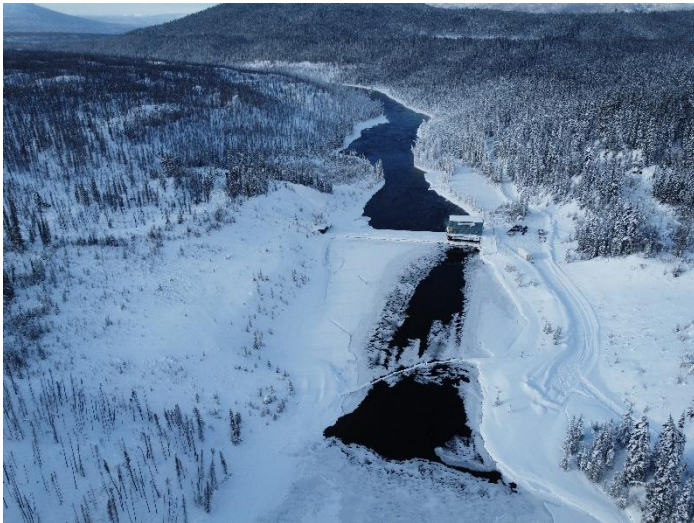
Lake Outlet

Unsafe to measure snow and ice due to open water

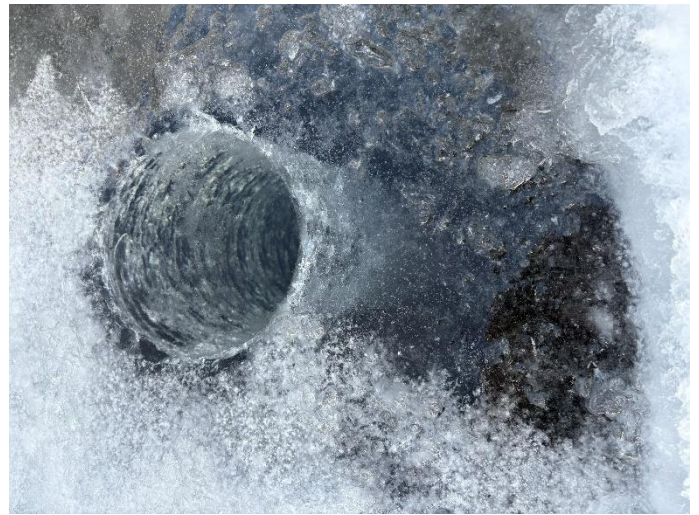
West End

Good quality black ice. Completely submerged ice hole (submerged by 1.9cm)

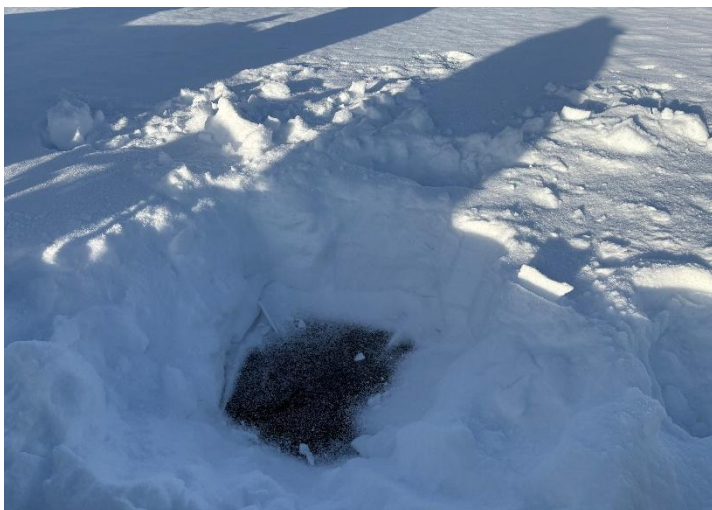
Middle of Lake

Good quality black ice with no overflow.

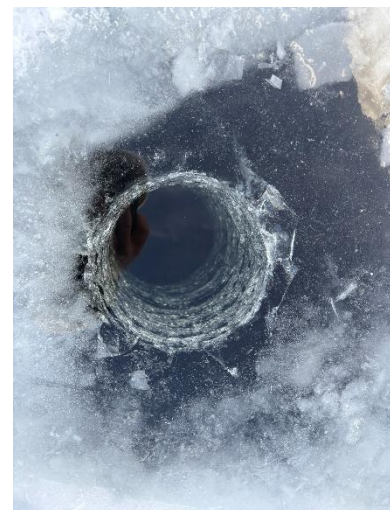
Nelson Arm Mid

Good quality black ice with back pressure causing water to flow out of hole, creating overflow.

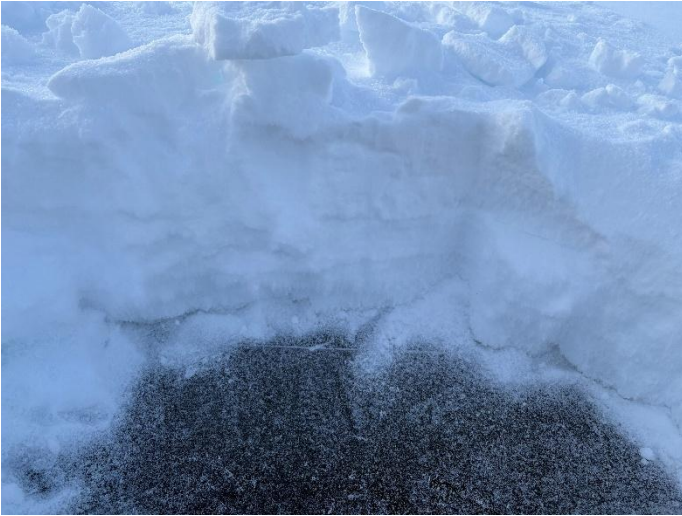
Roop Arm Mid

Spots of overflow going down middle of Roop Arm and along the shoreline. Good quality black ice.

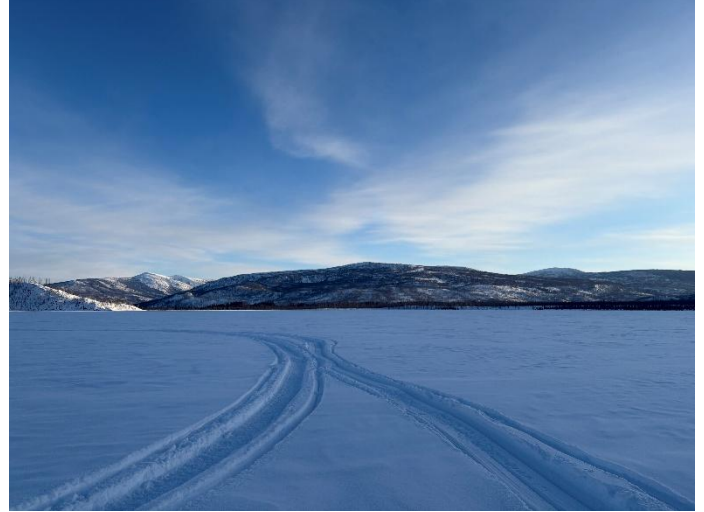
Roop Arm End

Good quality black ice with back pressure causing overflow (5.5cm of water on top of hole).

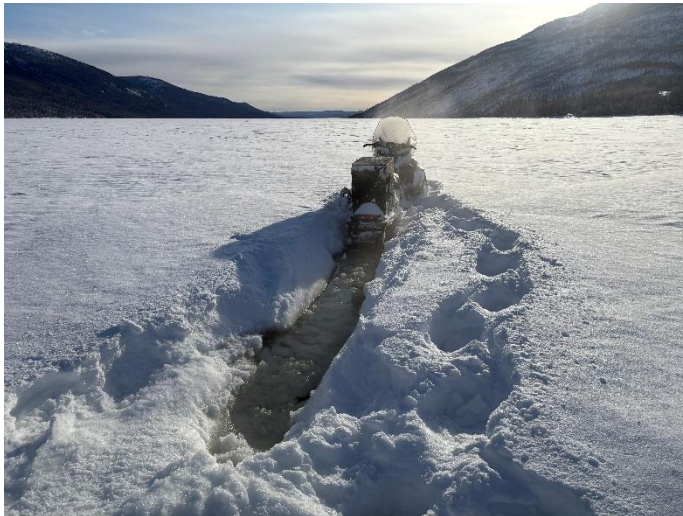
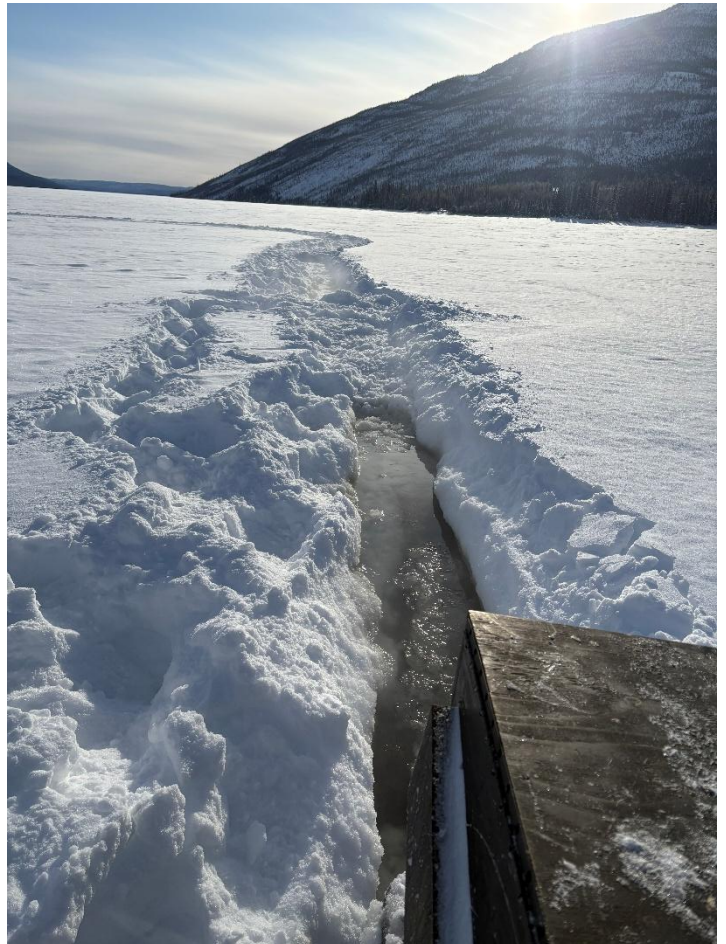
Nelson Arm End

Significant overflow along the shores and central arm. Overflow depths ranging from 30 to 45 centimetres deep. Significant snow load on the arm ranging from 40 to 70 centimeters. Was unable to reach the end of the arm with snowmobile (got really stuck in the overflow).
