Mirrlees Assessment Report

Yukon Energy KV-16 August 2016 Inspection

WD3 KV-16

FD1 KV-16

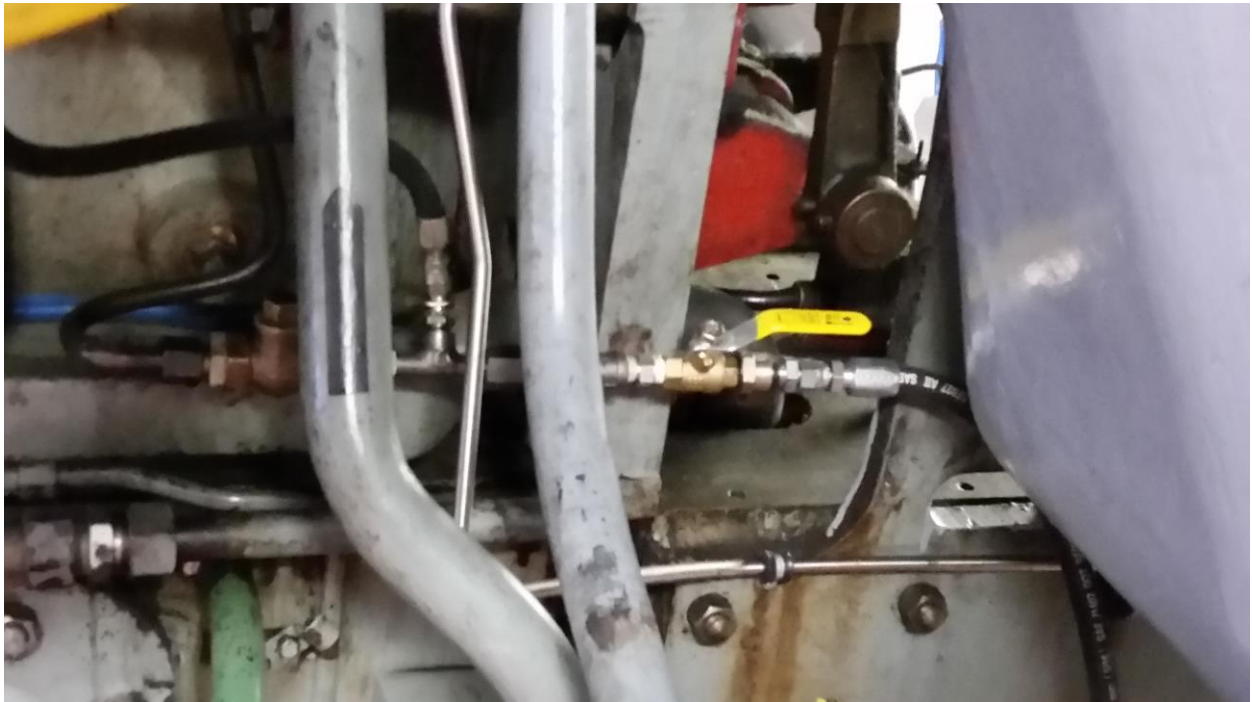
The lubricating rocker pressure regulator was removed from WD2 to replace the manual valve that was installed at the last overhaul. This valve was found to be defective and the manual valve was reinstalled. (This regulator valve could not be sourced by MAN at the last overhaul.)

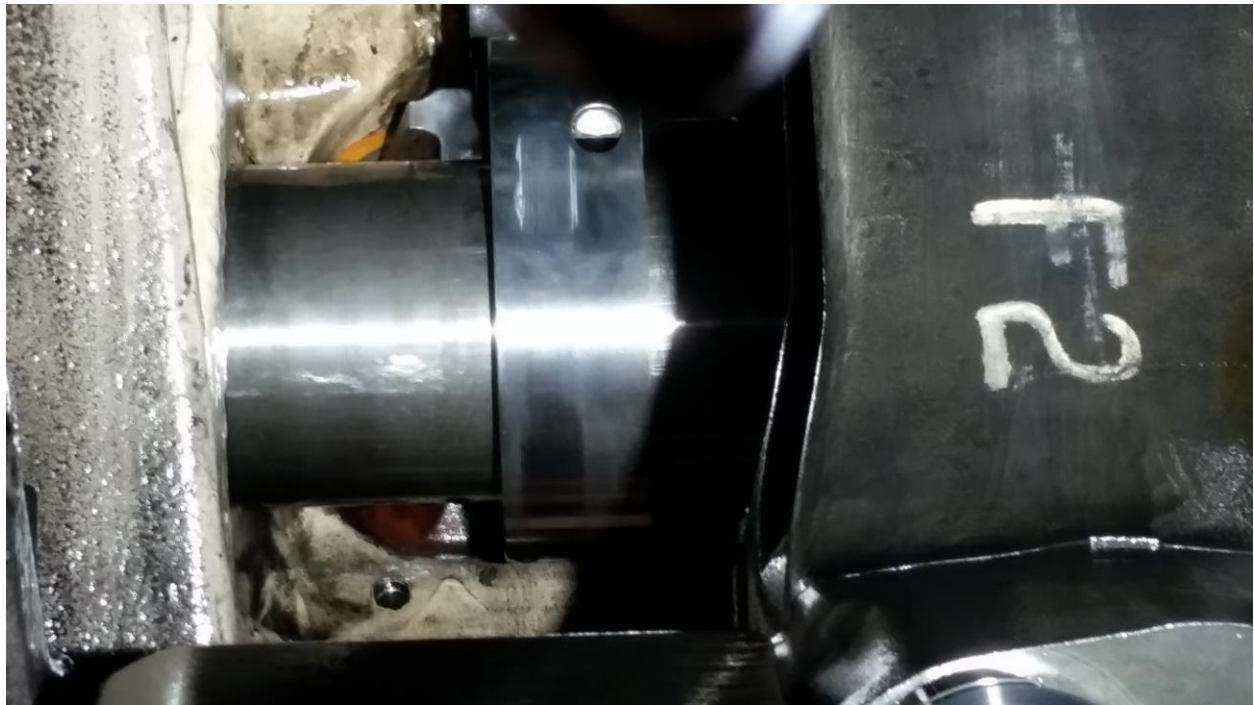
Visual signs of B6 exhaust cam (K22448) picking up. B6 crankcase door was removed.

Unable to inspect further due to type of clearance on the unit.

Recommend removal of cam door for more detailed inspection. If the cam needs to be replaced, this job could take up to a month after the parts are sourced.

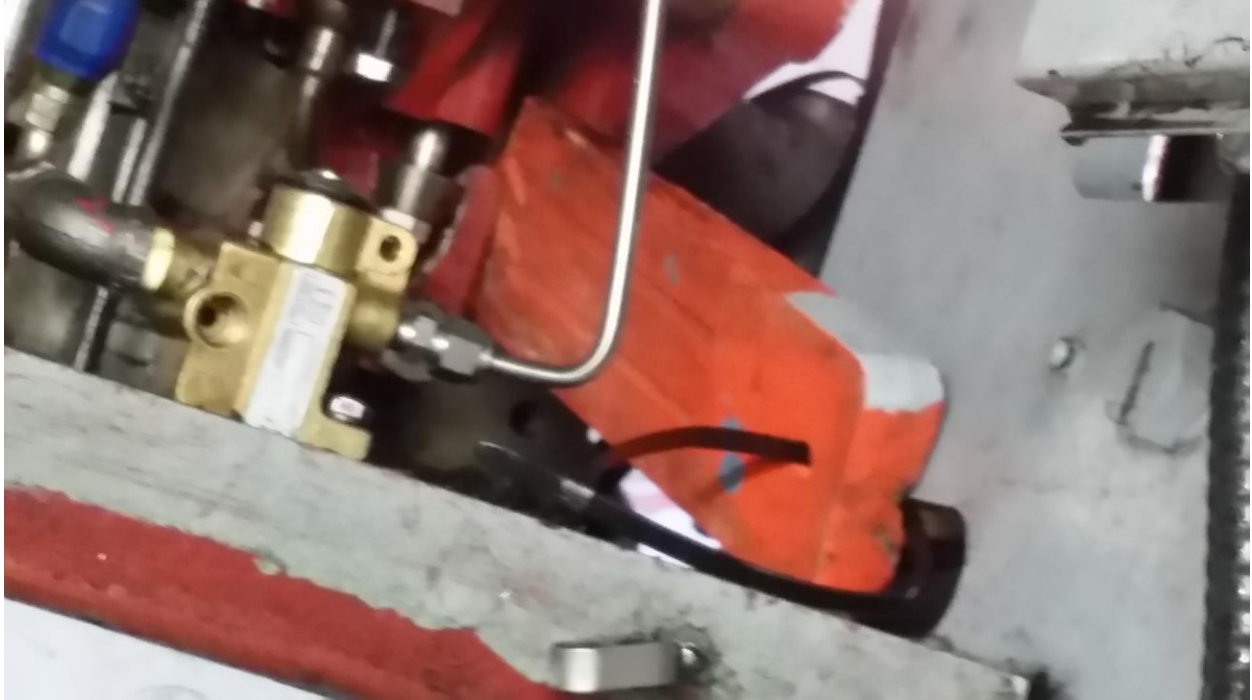
Mechanical emergency over-speed and low lube oil pressure trip shutdown blocked with a wedge. It was found that the unit trips off when running.

This could have a catastrophic failure if there is a governor failure.

Misalignment of the tripping lever mechanism is caused by movement of the cylinder block.

The mechanical overspeed trip and low lube pressure is now not operational and is relying on the electrical shut downs

Realignment of the tripping mechanism is needed; this could take up to a month to correct.
