Mayo Lake/Daghro Män/Ts'agro Män Ice Monitoring Program

February 2026

Ice Observation – Feb 20, 2026

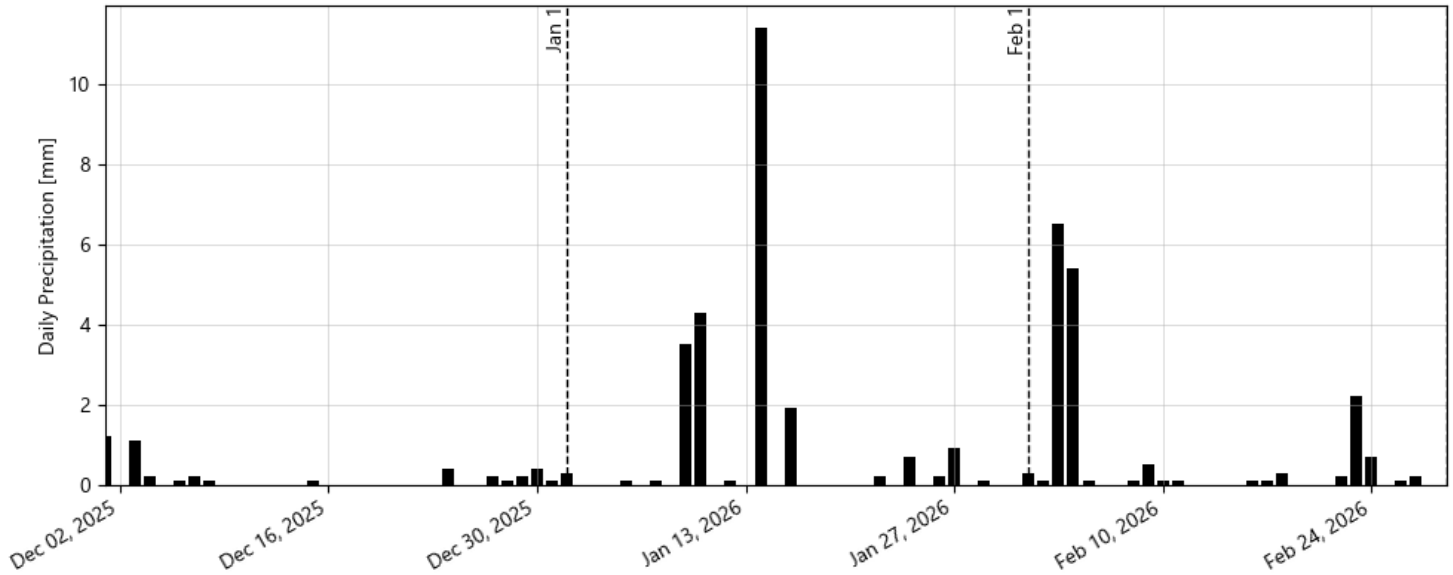
Daily Precipitation Totals

- a. Precipitation observations are from Mayo Townsite (EC54178)
- b. Temperature observations are from Mayo Lake Control Structure site

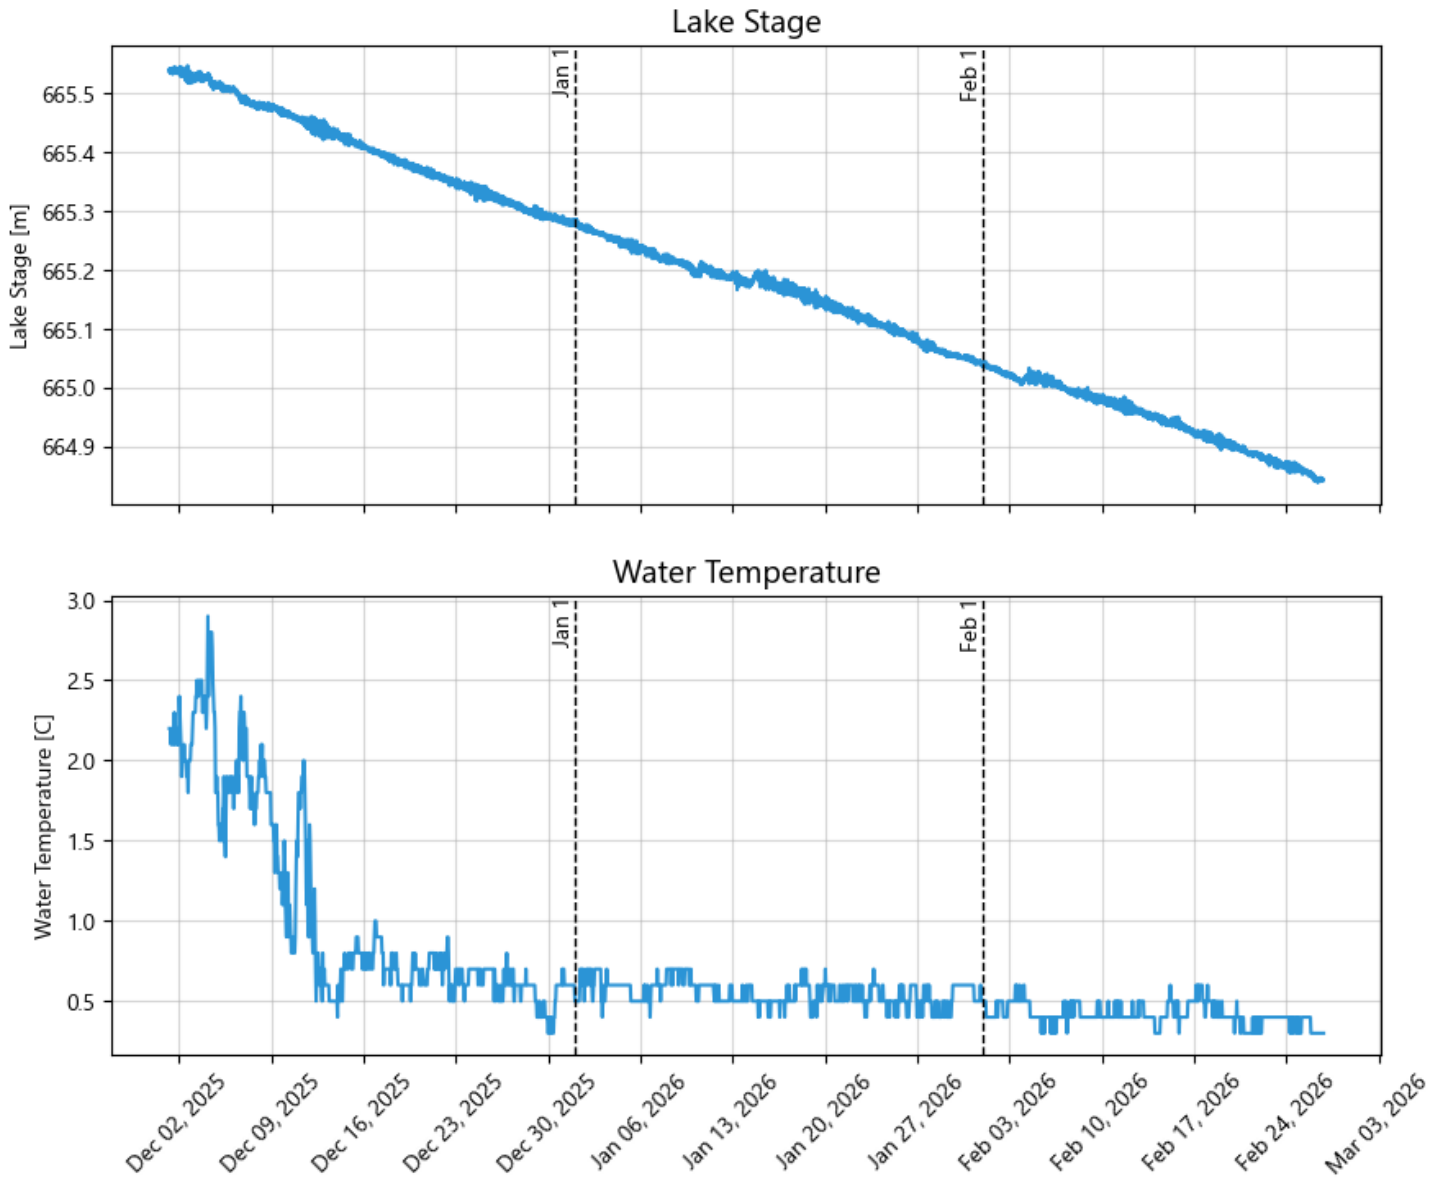
Lake Observations

- c. Lake observations are from Water survey of Canada gauge 09DC005 near the outlet of Mayo Lake
