Yukon Energy Corporation

# **Marsh Lake Storage Concept: 2011 Geomorphology Field and Associated Studies Report**

AECOM

December 2011

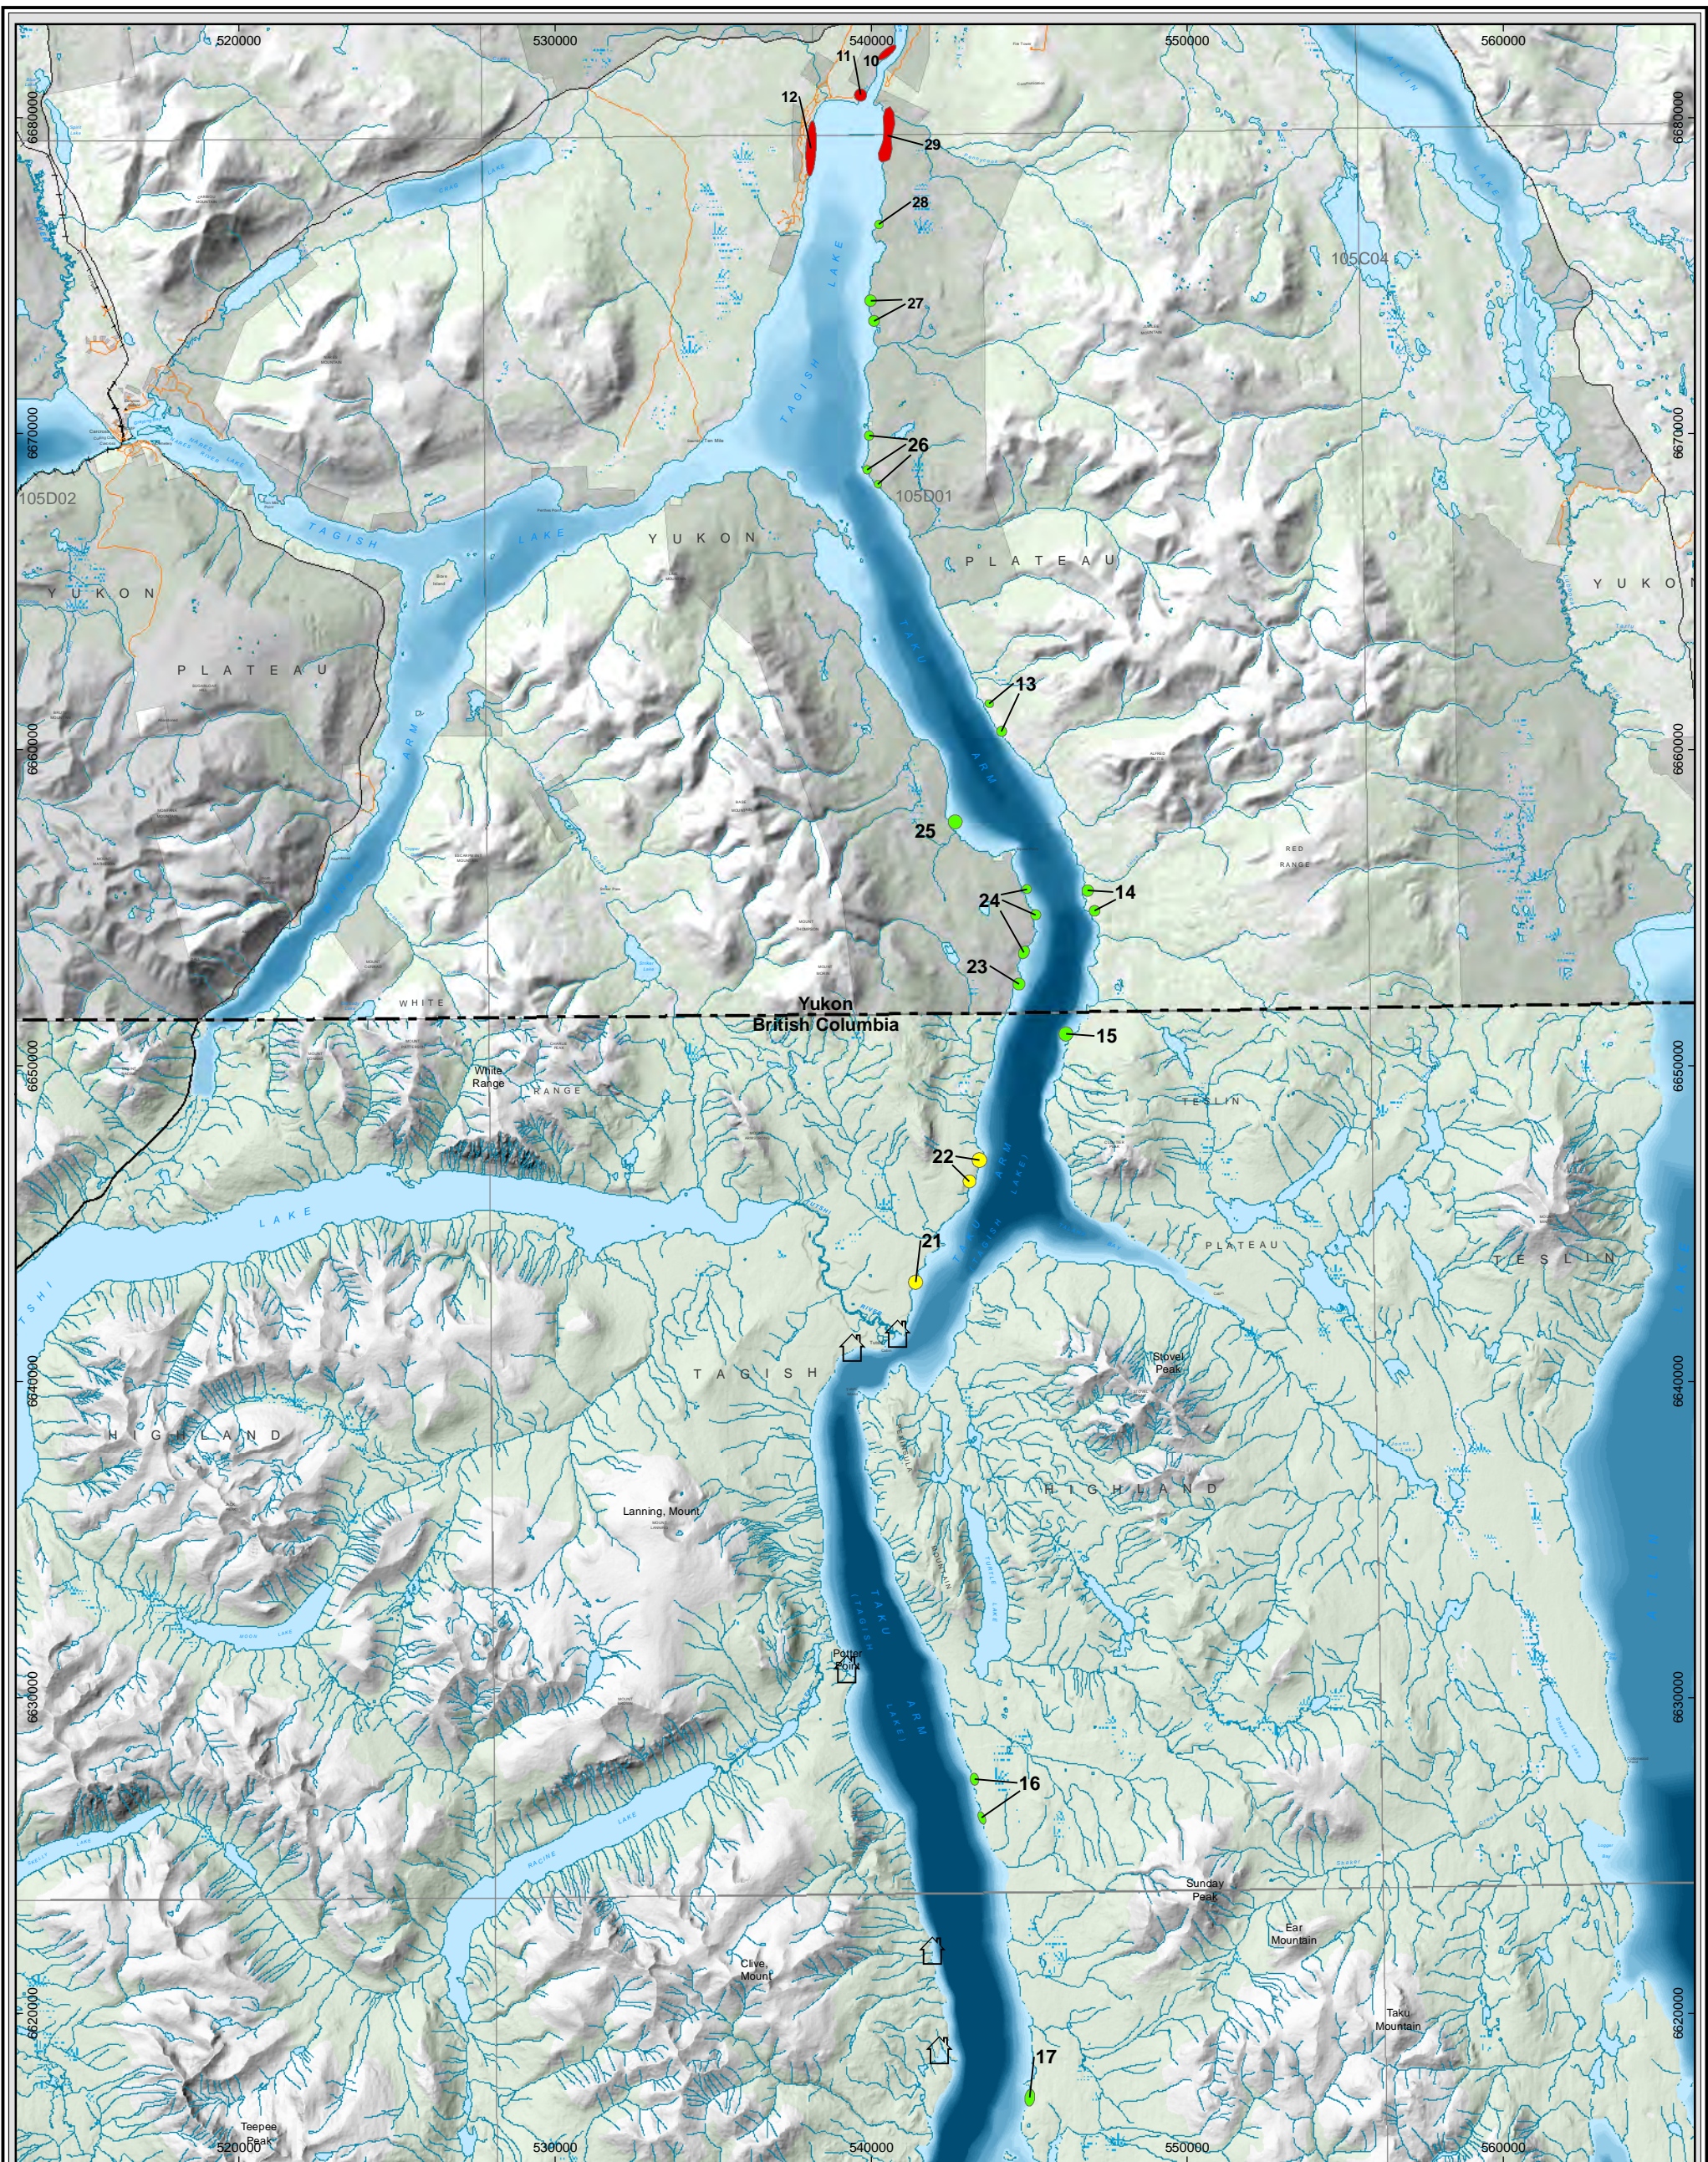
Figure 2-2

The surface geology map of the Marsh and Tagish Lake area (Morison and Klassen 1991) is quite coarse in resolution, however, it does help explain some of the shoreline erosion observed. The north end of Tagish Lake has two large areas with a high rank of erosive shoreline (Figure 2-2: #12 and #29). In addition to the aspect of these shorelines, the surface geology mainly consists of high banks of a glaciolacustrine deposit consisting of clay, silt and sand. These deposits are not cohesive and thus very susceptible to erosion. The high ranking areas along the Tagish River (Figure 2-2: #10 and #110) are also characterized by a surface geology consisting of a glaciolacustrine deposit (Morison and Klassen, 1991). In addition to wave attack, erosion by moving water within the Tagish River is likely contributing to the high level of erosion here.

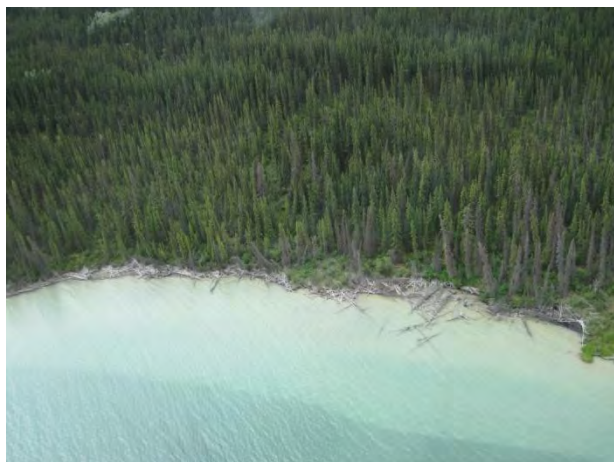
**Photograph 1**

'Drunken forest', with minor bank erosion and turbid water at shore.

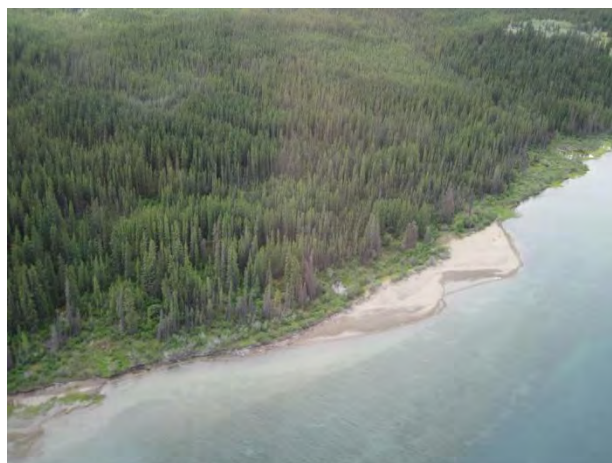
**Photograph 4**

Accretion of sand along shore.

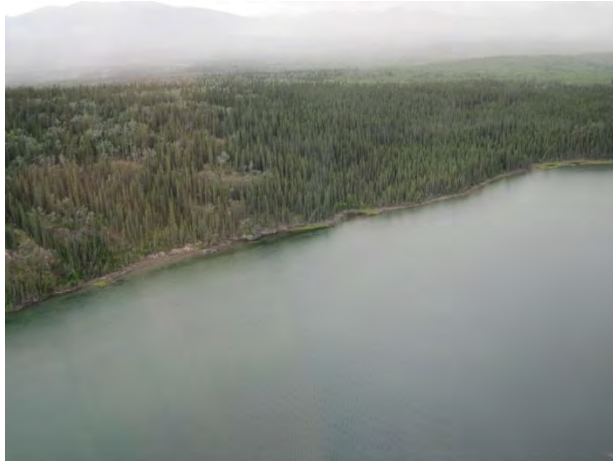
**Photograph 5**

Fine grained sediment eroding along high bank.

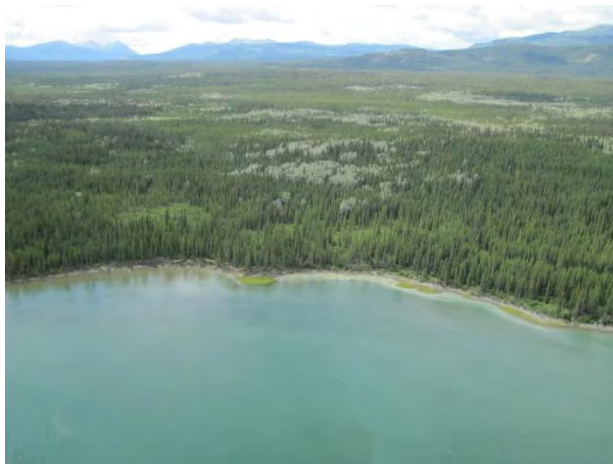
**Photograph 7**

Fine grained sediment eroding at low bank.

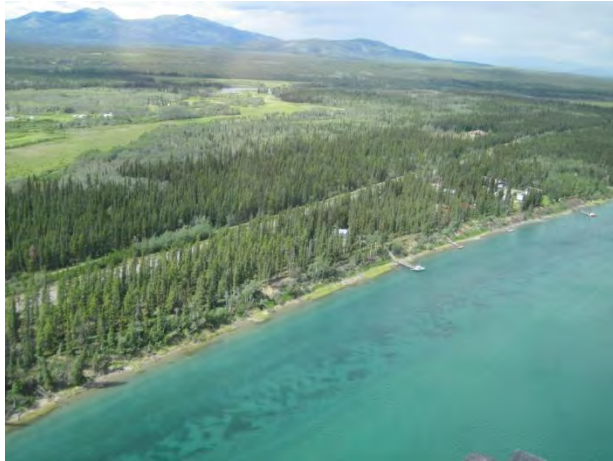
**Photograph 9**

Fine grained sediment eroding along high bank. Houses all along bank.

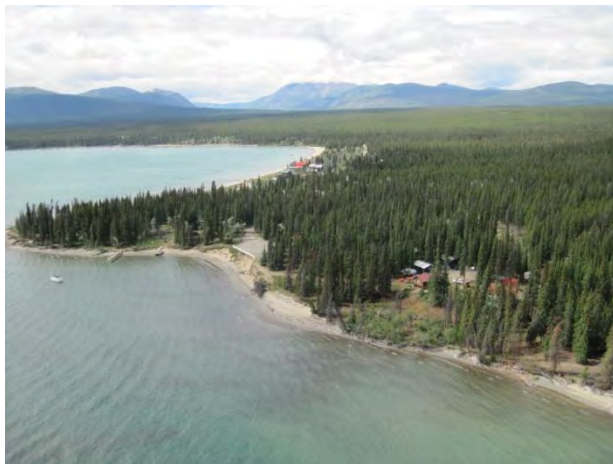
**Photograph 11**

High, fine grained bluff eroding along Tagish River.  
Houses all along eroding bank.

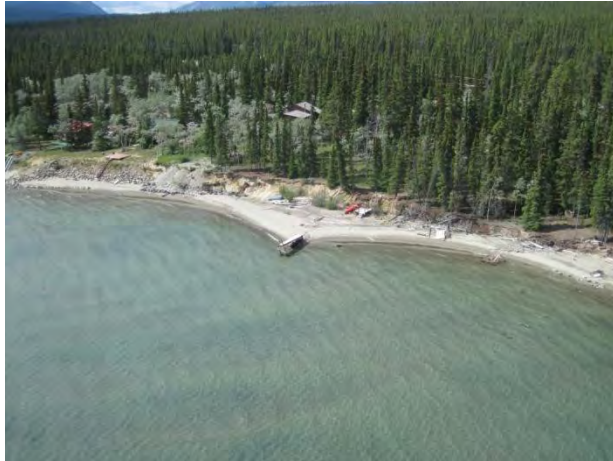
**Photograph 13**

Fine grained sediment eroding along high bank. Houses all along bank.

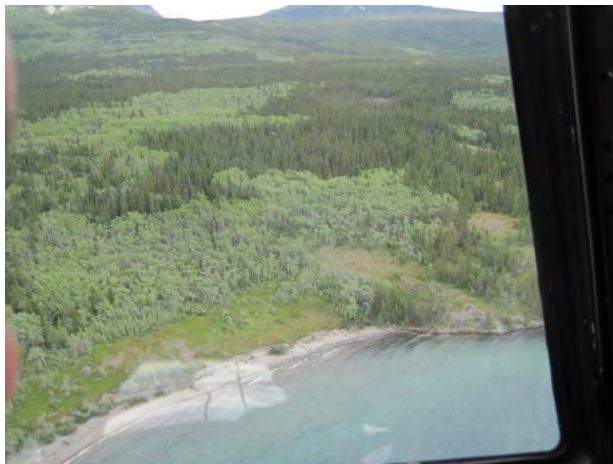
**Photograph 15**

Low, fine grained bluff eroding.

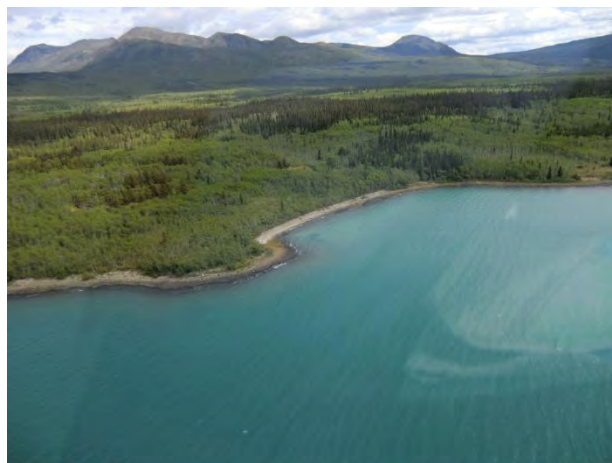
**Photograph 18**

Fine grained sediment eroding along high bank.

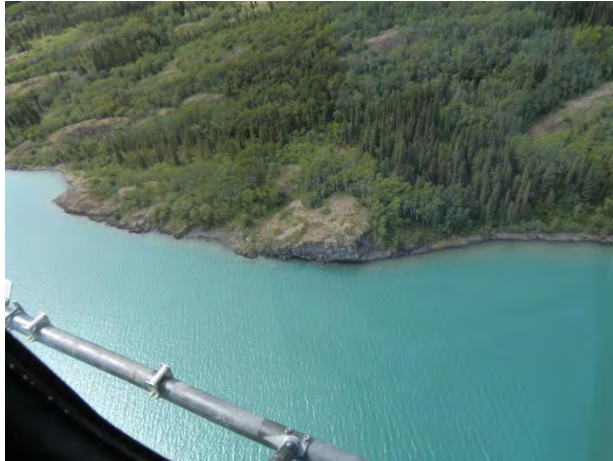
**Photograph 21**  
Undercut erosion on bedrock cliff.

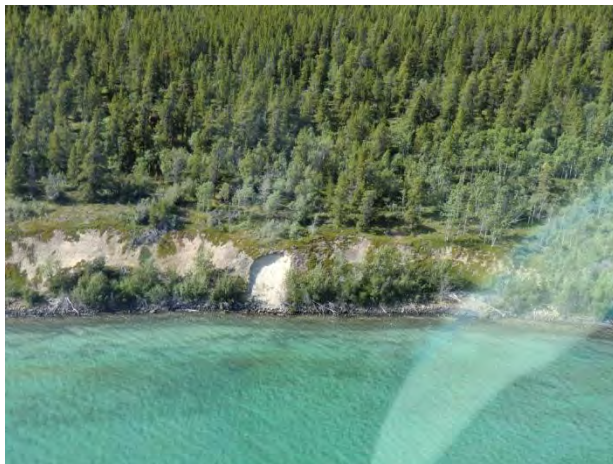
**Photograph 23**  
Slumping fine grained sediment eroding on high bank.

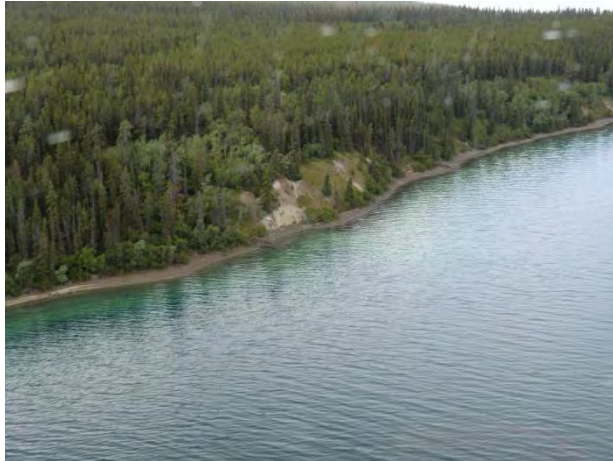
**Photograph 25**

High bank erosion of fine grained sediment.

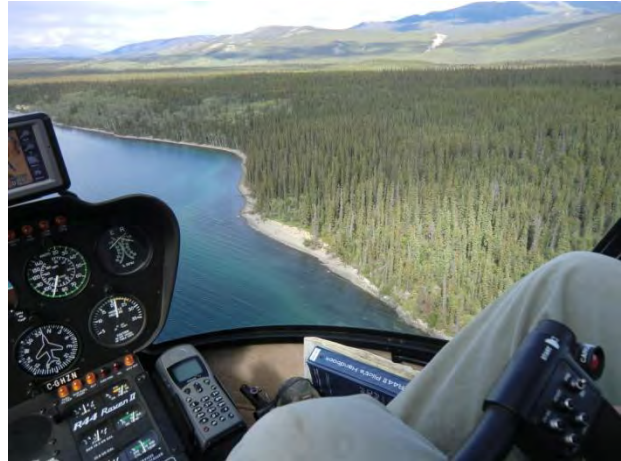
**Photograph 26**

Low bank, fine grained sediment eroding along shore.

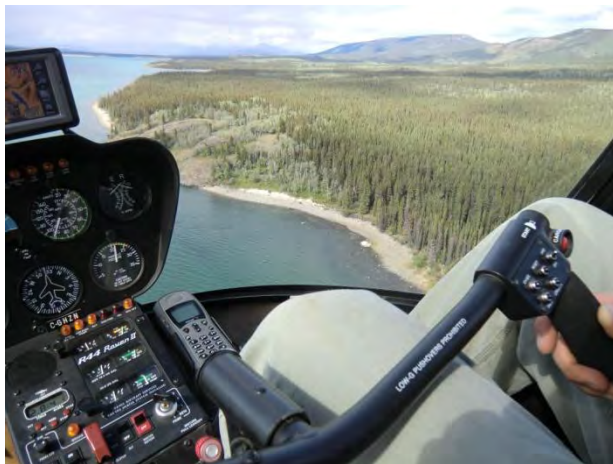
**Photograph 27**

. Low bank, fine grained sediment eroding along shore.

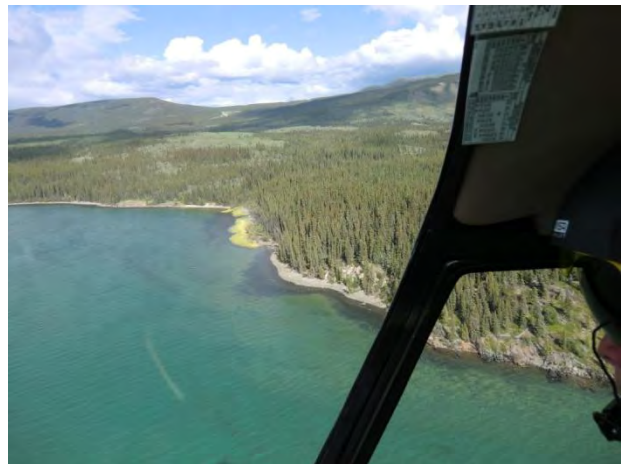
**Photograph 28**

High bank erosion of fine grained sediment.

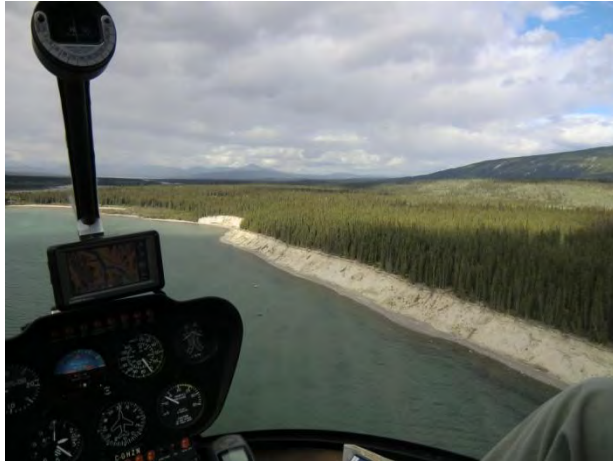
**Photograph 29**

High bank erosion of fine grained sediment.

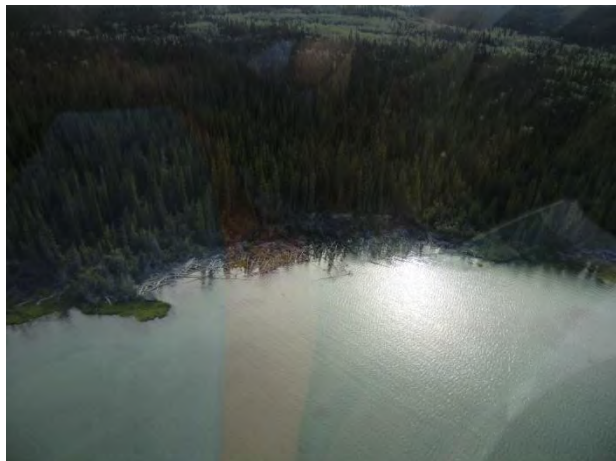
**Photograph 33**

Low bank, fine grained sediment eroding along shore.

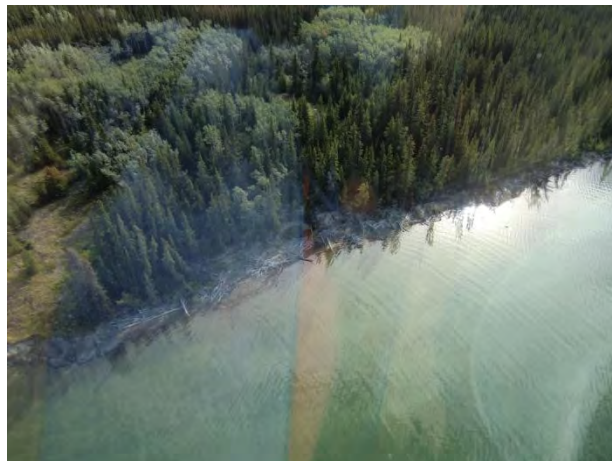
**Photograph 34**

Low bank, fine grained sediment eroding along shore.  
'Drunken forest' offshore.

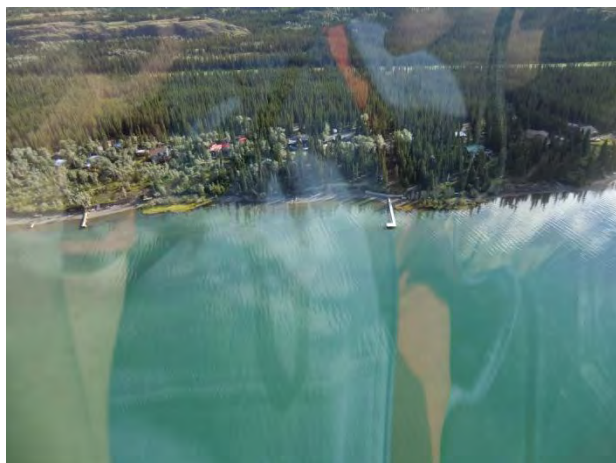
**Photograph 37**

Low bank, fine grained sediment eroding along shore.  
Properties/houses along shore.

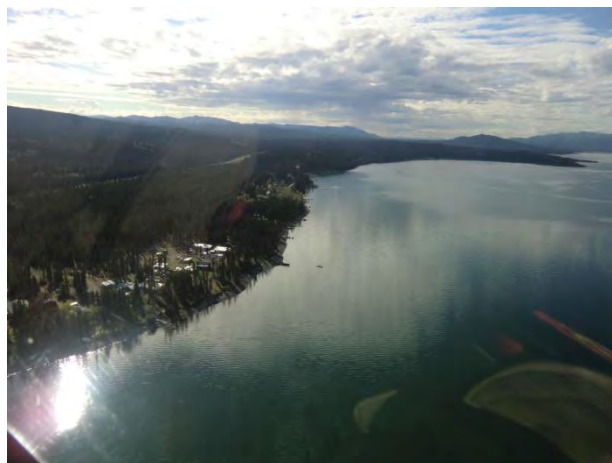
**Photograph 38**

Low bank, fine grained sediment eroding along shore.  
Properties/houses along shore.

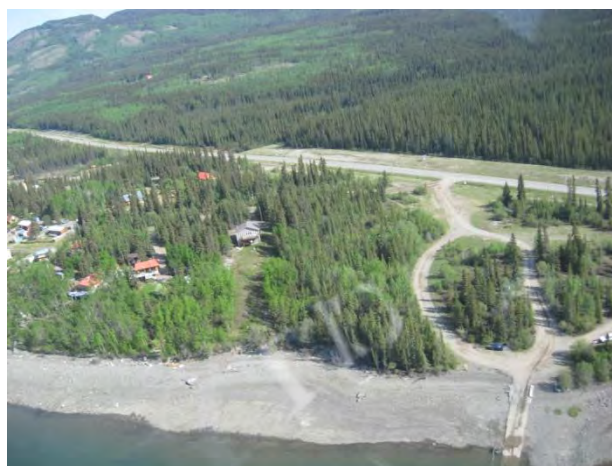
**Photograph 40**

Low bank with fine grained sediment eroding along shore. Boat launch adjacent to erosion.

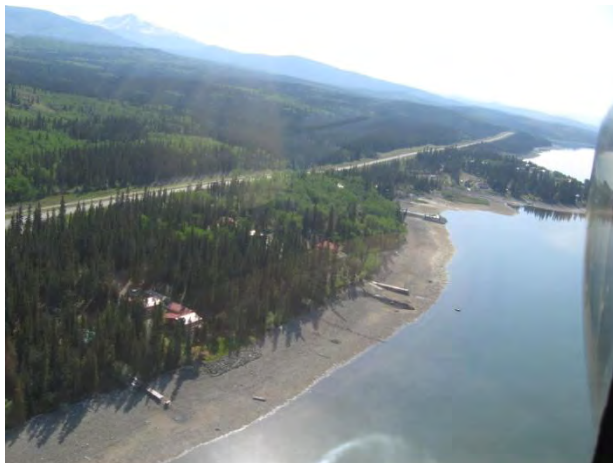
**Photograph 41**

Low bank, fine grained sediment eroding along shore.  
Properties/houses along shore with revetment.

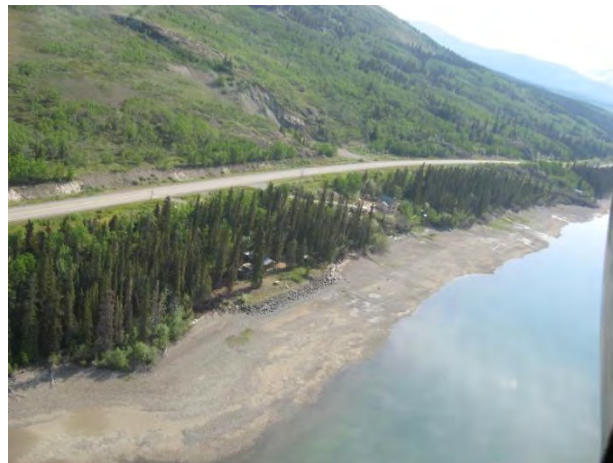
**Photograph 42**

Low to medium high bank, fine grained sediment eroding  
along shore. Rich Muelleur's property flanks erosion on  
both sides.

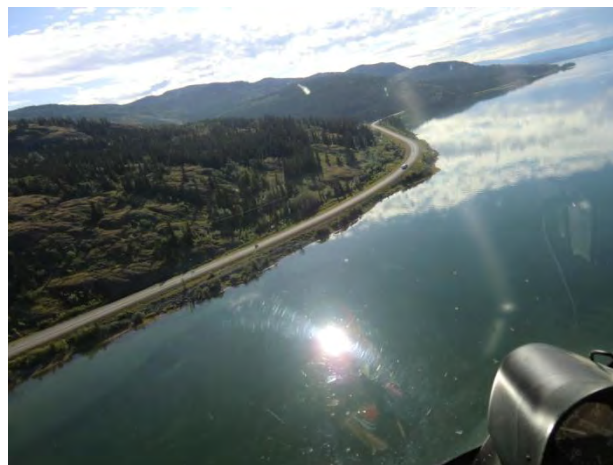
**Photograph 44**

High bank with revetment along highway, erosion is  
evident along shore.

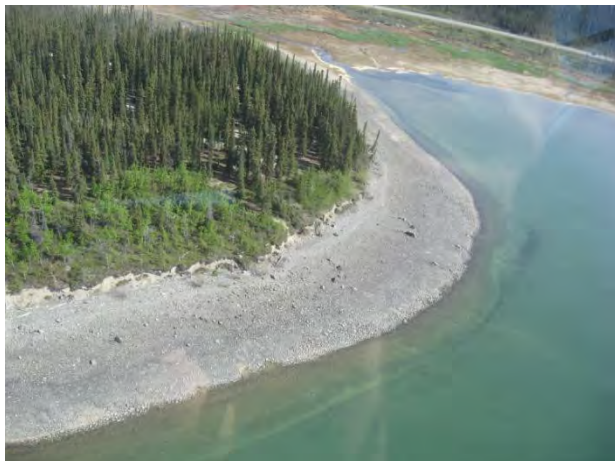
**Photograph 45**

Low bank, fine grained sediment eroding along shore.

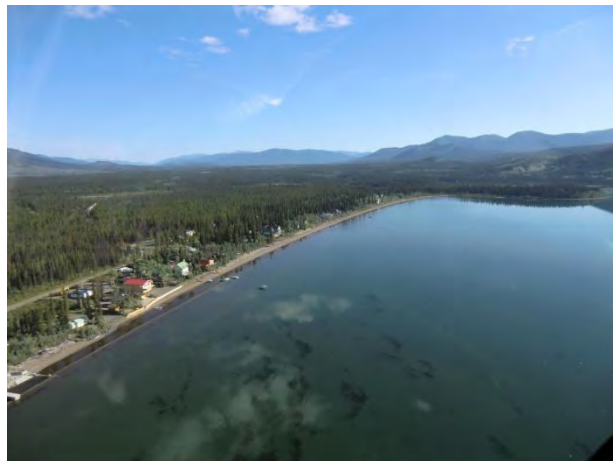
**Photograph 46**

Low bank, fine grained sediment eroding along shore. Army Beach properties all along shore, most with some form of revetment.

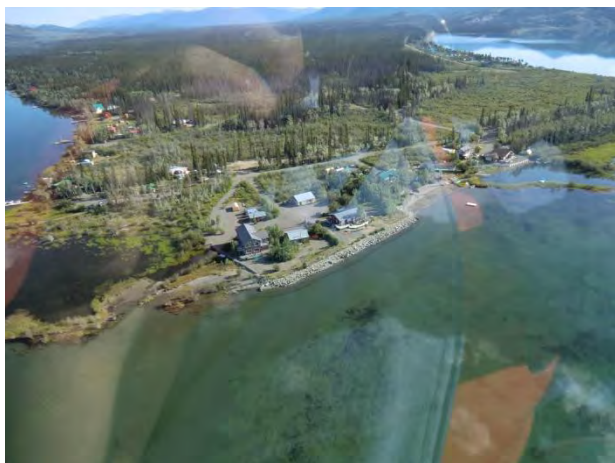
**Photograph 47**

Low bank, fine grained sediment eroding along shore. Bank is largely protected.

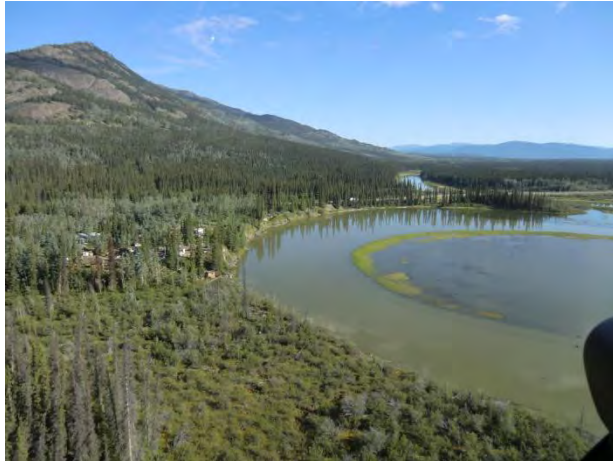
**Photograph 48**

Low bank with fine grained sediment eroding along shore. Bank erosion appears to be from M'Clintock River.

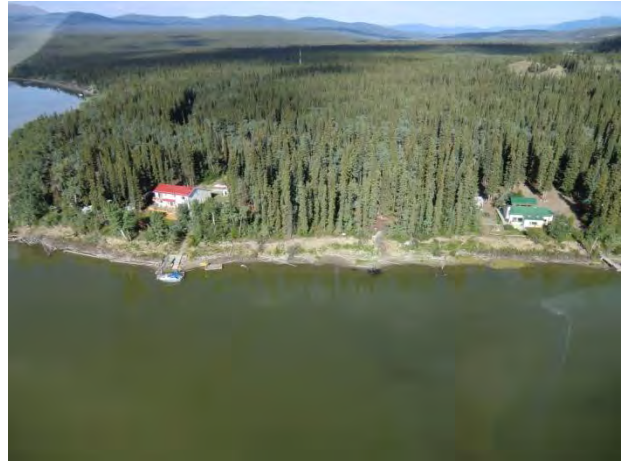
**Photograph 49**

Low to medium high bank with fine grained sediment eroding along shore. Bank erosion appears to be from M'Clintock River

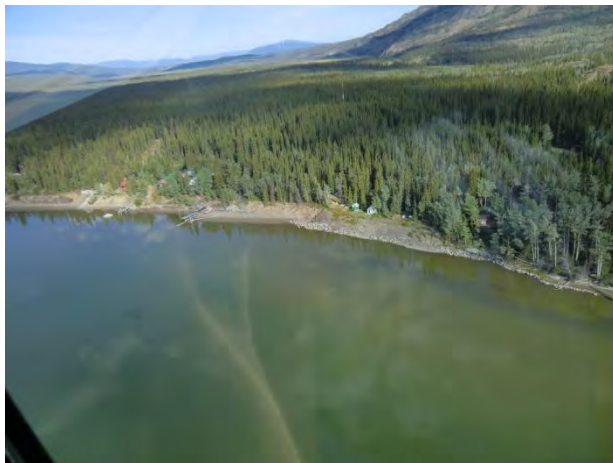
**Photograph 50**

- North M'Clintock/Swan Haven Erosion Modeling
  - Numerically model interaction of M'Clintock River and wind waves at bluff adjacent to several homes and a First Nations cemetery and over mudflats important to swans. This can be done in a two-phase program depending on agency requirements. The first is to do a HEC\_RAS model primarily focusing on erosion caused by the M'Clintock River. The second modeling effort would utilize a two-dimensional hydrodynamic model of Marsh Lake to predict depositional and erosional forces on the lakebed/mudflats in the Swan Haven area. The model results will provide additional insight into risks of changes to the mudflats important to migratory swans under a range of water levels and seasonal conditions. It will also augment understanding of the erosive effects of the M'Clintock River.

High bank with fine grained sediment eroding along shore. North M'Clintock properties adjacent to erosion.

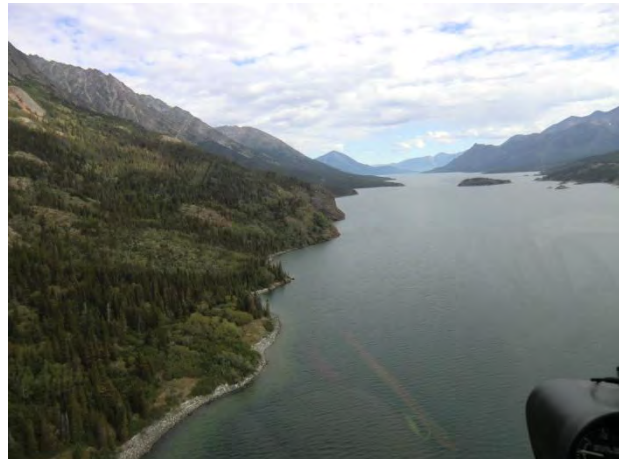
**Photograph 55**

Figure 2-4 shows the locations of erosion occurring on Bennett Lake. Only one location on Bennett Lake was identified (#1 on Figure 2-4) as an eroding shore of fine grained sediment (Photo 55, Appendix A). With the exception of the White Pass & Yukon Railway (WP&YR) embankment, the majority of the Bennett Lake shoreline is stable and contains naturally well armoured beaches (Photo 56, Appendix A). An erosion ranking system was not employed along the shoreline adjacent to the WP&YR (which parallels the majority of the southeast shoreline); rather all locations along the railway that appeared to have had recent revetment repair were noted and are shown in Figure 4. Several long sections of the WP&YR are located immediately adjacent to the shore of Bennett Lake. In most instances, these sections of railway embankment are experiencing erosion from wave attack (Photos 53 and 54, Appendix A). As a result, WP&YR has historically performed regular repair of its embankment.

Low to moderate high bank with fine grained sediment eroding along shore of Bennet Lake.

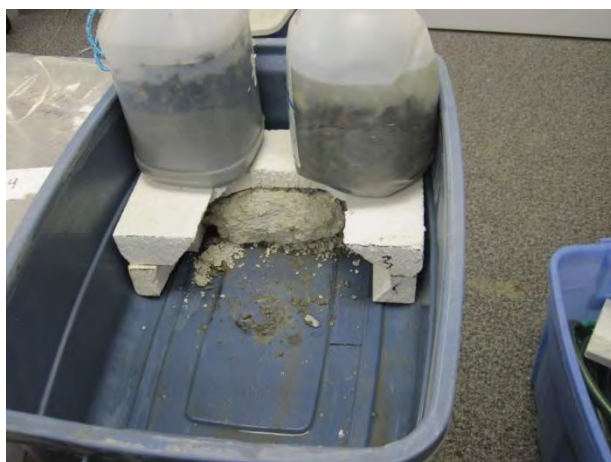
**Photograph 70**  
Turbid water resulted even when no agitation was conducted.

In all trials, a significant portion of the clay sample dispersed in the water, with a small amount of 'pudding' remaining on the bottom of the Rubbermaid container. As expected, the higher agitation trial resulted in a faster rate of deterioration (Table 6-1). During the two trials with no agitation, both samples deteriorated after 2 minutes, yet one sample was more than twice as heavy as the other. The results emphasize the weakness of these particular soils under even minor wave agitation. The presence of revetment did slow the decay of these samples (Table 6-1).

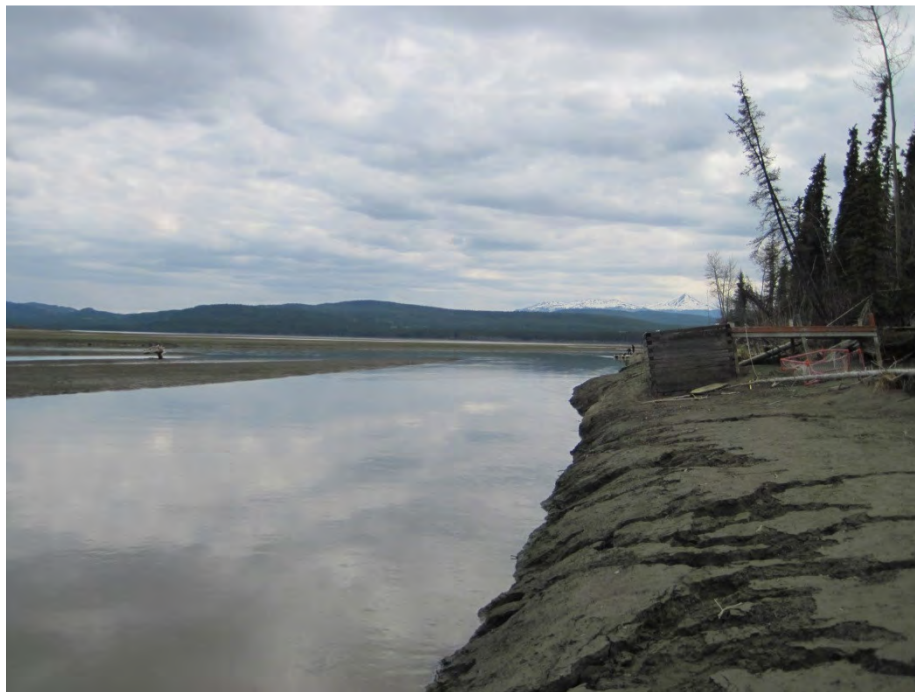
**Photograph 1.** Small sand/silt spit at north end of M'Clintock Bay, north extent just beyond view on left side of photo.

- A small sand/silt spit was observed immediately north of Lot 1039. The approximate area of the spit was 250 m<sup>2</sup> and was about 1.0 m in height (Photo 1). This suggests that wave action may be transporting and depositing eroded bank and bluff sediments northwards along the beach of North M'Clintock.

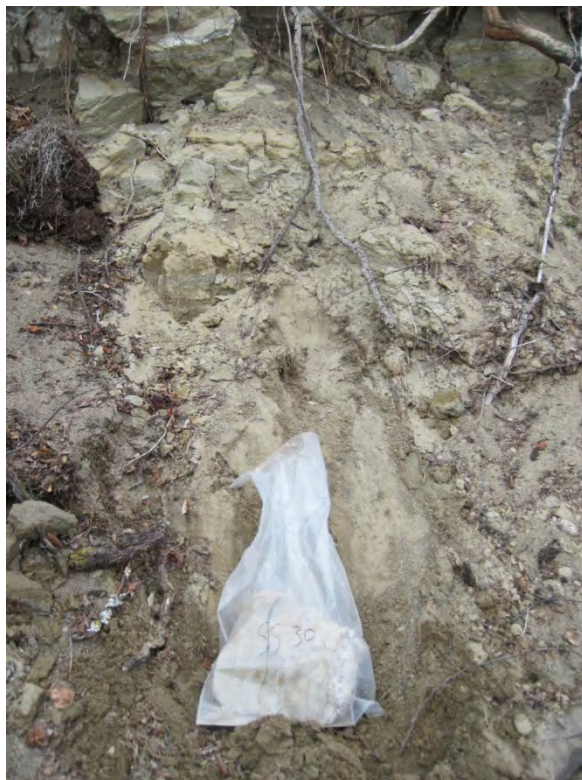
**Photograph 6.**

- A sediment sample (SS30) of the eroding silt/sand bluff (Photos 6 and 7) north of the bedrock outcrop was collected (E527697, N6712946, 08V).
- The bluff near Lots 396 and 1027, south of the bedrock outcrop on North M'CLintock (Photo 8), is shorter and experiencing less erosion than Lots situated north of the bedrock outcrop.

Typical silt deposit that consist of the erosion bluffs along North M'Clintock.

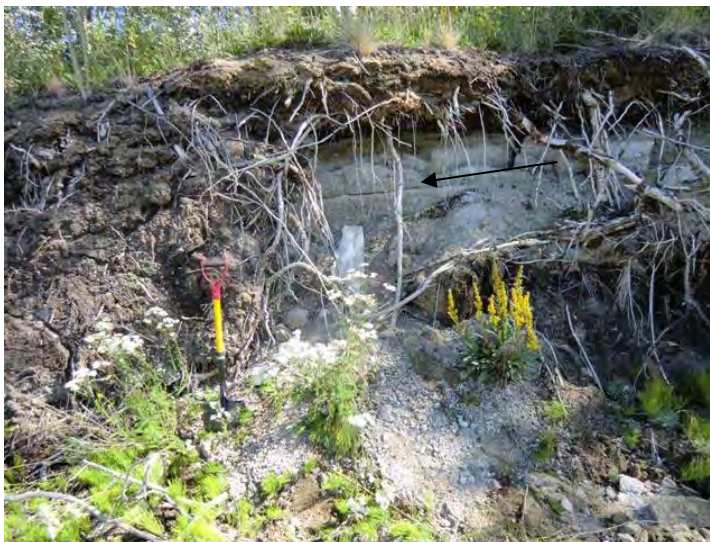
1. Preliminary topographic survey of shoreline in front of Lot 77, Judas Creek Subdivision using Vertex height measurer (see Figure 1). Sediment samples collected on from cutbank (photograph 1).

**Photograph 1.** Sediment collection point near Lot 77

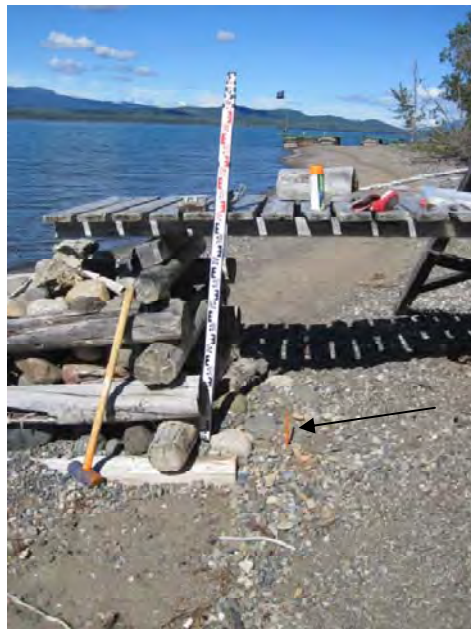
2. Demarcation of proposed FSL with rebar installed near dock post adjacent to Lot 77. Top of rebar represents proposed FSL (656.54 mASL). Rebar may sink over winter due to soft substrate underlying beach gravel.

**Photograph 2.** Proposed FSL rebar installed (Lot 77)

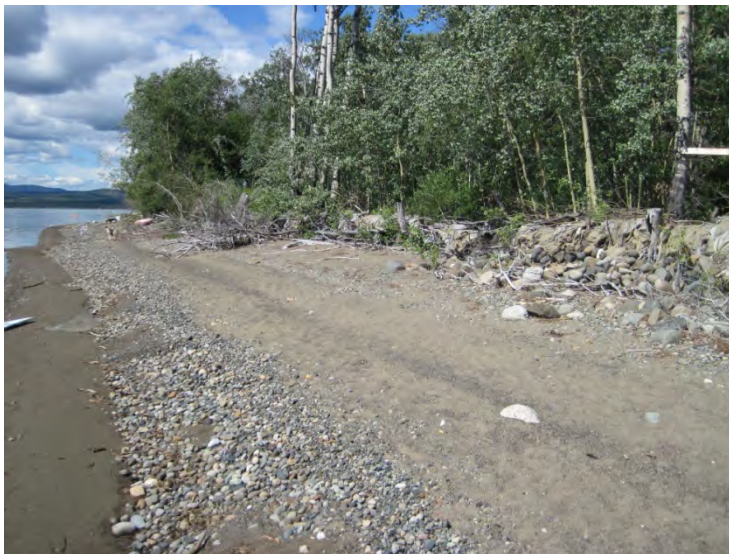
3. Visit to low properties in Judas Creek Subdivision to survey transect up beach:
  - Lot 83 – Elevation at toe of slope is 656.6 mASL; land behind sand bags is at 657.1 mASL.
  - Lots 135-137 – Elevation at fence is 657.4 mASL; guest house foundation is at 658.2 mASL.

**Photograph 3.** Shoreline at Lot 83

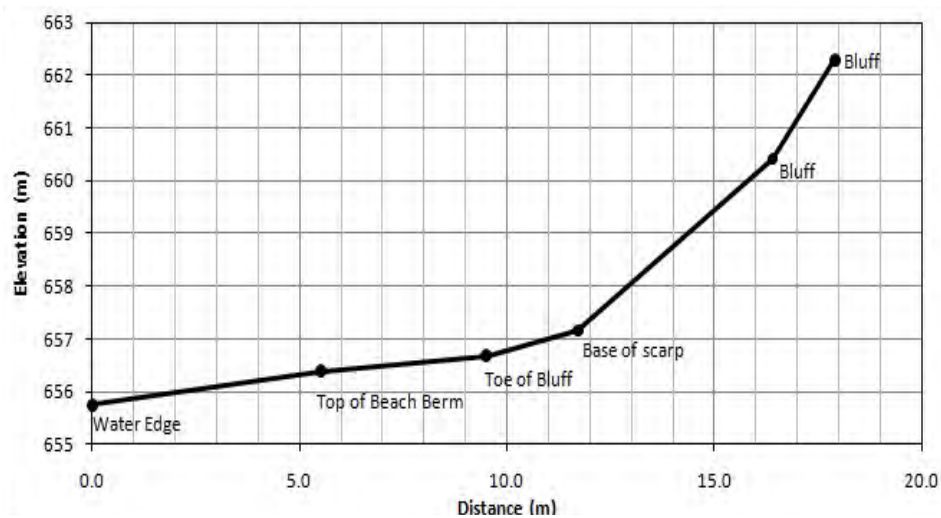
4. Visit to shoreline bluff south of KDFN S-206 along Alaska Highway – high glacio-lacustrine bluff subject to erosion. Beach transect presented in Figure 2.

**Figure 2.** Beach transect at shoreline bluff south of KDFN S-206
